# Monitoring of the corrosion behaviour of the reinforcement at a cooling tower working in sea water operation using embeddable polymeric cathode sensors

Michael Raupach<sup>1\*</sup>, Christian Helm<sup>1</sup>, and Helena Eisenkrein-Kreksch<sup>2</sup>

<sup>1</sup>Institute of Building Materials Research (ibac), RWTH Aachen University, Germany

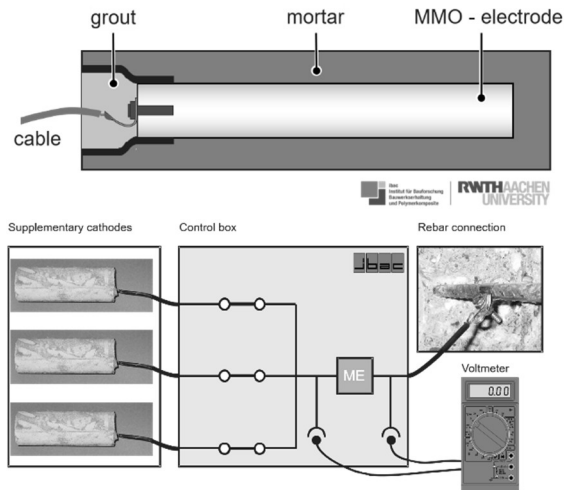
**Fig. 1.** Top: Structure of a supplementary cathode. Bottom: Illustration of the supplementary cathode measurement system.

In previous applications of this method, noble metal electrodes or mixed metal oxide (MMO)-coated titanium electrodes were typically embedded in mortar to minimize the risk of short circuits to the reinforcement and subsequently installed in drilled holes using grout, see Figure 1.

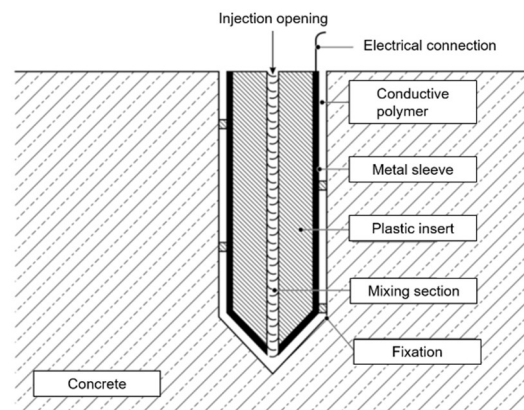
**Fig. 2.** Principle sensor schematic.

Unlike the previously presented approaches, this sensor does not rely on a mineral-based coupling. Instead, coupling is achieved through a polymer that is sufficiently electrically conductive and exhibits favourable polarization properties. The electrical connection and a sufficiently positive electrochemical potential are ensured by a metal core, which also serves as the electrical contact point. A schematic representation of the sensor is shown in Figure 2.

Furthermore, the core should be designed to both centre the sensor within the borehole and serve as a mixing channel for the injection of the 2K sensor polymer.

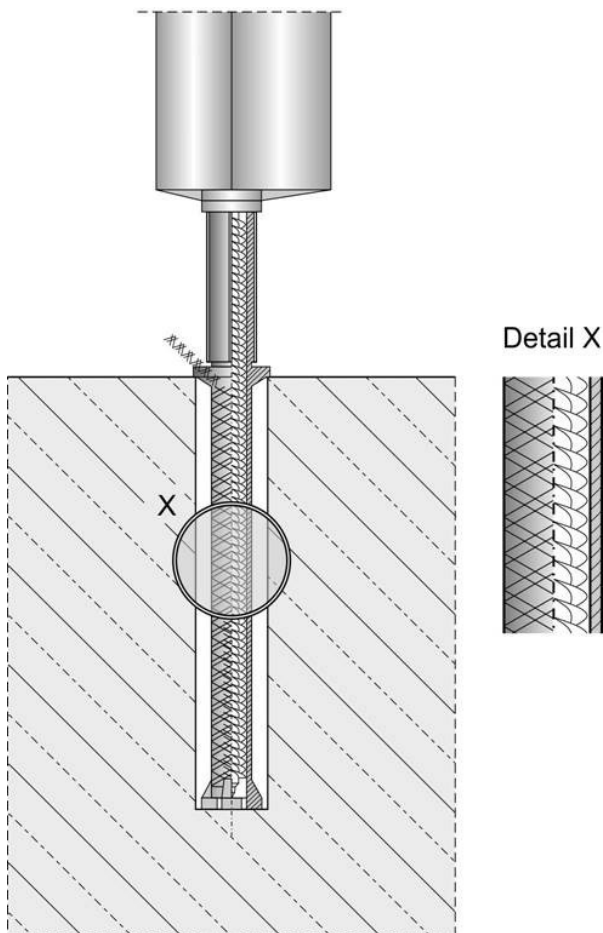
**Fig. 3.** Final sensor geometry.

The latter is achieved because the coupling material consists of a system with negligible water absorption, where ion conduction occurs through so-called defect introduction. The corresponding laboratory investigations are described in detail in [5]. A schematic representation of the sensor geometry, as used in the practical application described here, is shown in Figure 3.

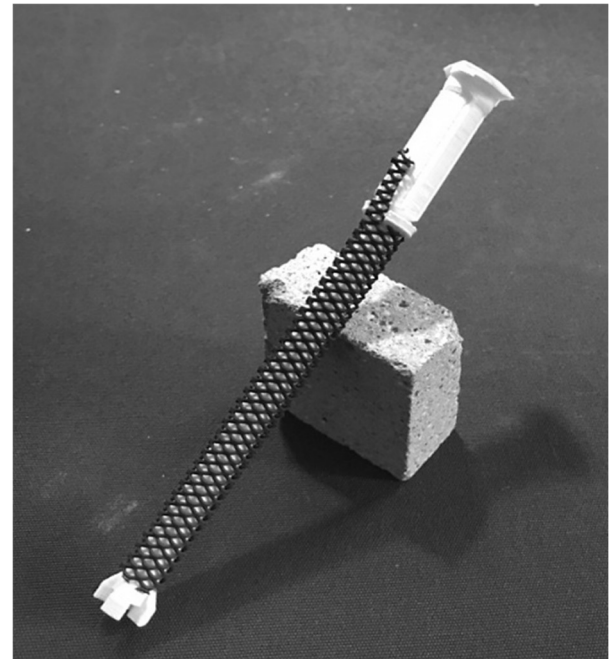
**Fig. 4.** Photographic sensor illustration.

A photographic image of the sensor is shown in Figure 4. The cathode carrier with an internal mixing channel is visible, enclosed by a mesh of MMO. The thickened base centres the sensor within the borehole, ensuring complete encapsulation by the polymer, which exits at the foot. The upper collar secures the sensor in place through friction, preventing movement within the borehole.

The top connector allows attachment to a standard 2K syringe and is detached from the sensor at a predetermined breaking point after the annular gap is fully filled. The curing time of the sensor polymer can be chemically adjusted and also depends on external conditions, particularly temperature.

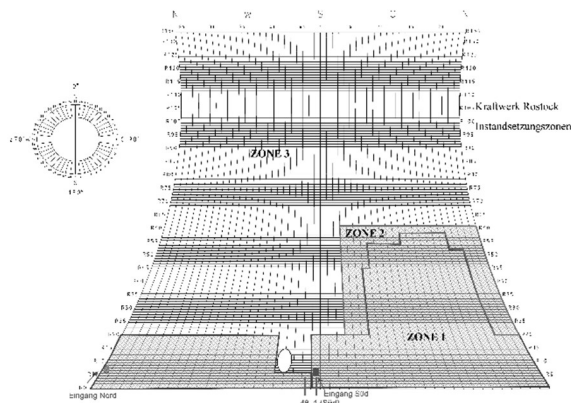
**Fig. 5.** Representation of the repair-related zones 1 to 4, with Zone 4 encompassing the entire shell.

Based on the investigation results and the alignment of chloride sampling, potential field measurements, and identified voids, the shell has been divided into four zones, each of which is to undergo different measures. The individual zones are shown in the shell development diagram in Figure 5.

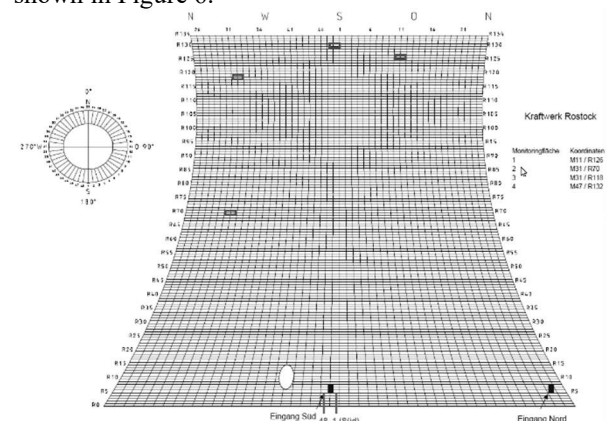
**Fig. 6.** Location of the measuring points.

A system based on the previously described supplementary cathode principle was chosen. A total of five measurement fields were arranged to monitor the success of the repair, representing the zones defined in section 2.4. The location of the measurement fields is shown in Figure 6.

For each measurement field, 8 sensors were distributed over an area of approximately one square meter. The distribution was random, with the only prior step being the non-destructive determination of the reinforcement location to avoid hitting reinforcement during the drilling process. A total of 5 sensors from the new polymer sensor type were installed, as shown in Figures 3 and 4. Additionally, 3 "classic" supplementary cathodes, as shown in Figure 1, were embedded in the boreholes. This setup was intended to allow a comparative evaluation of the two sensor types, as well as to ensure the durability of the monitoring system. While the established form of the supplementary cathode has long-term experience, the polymer sensors had only been tested in the laboratory scale so far.

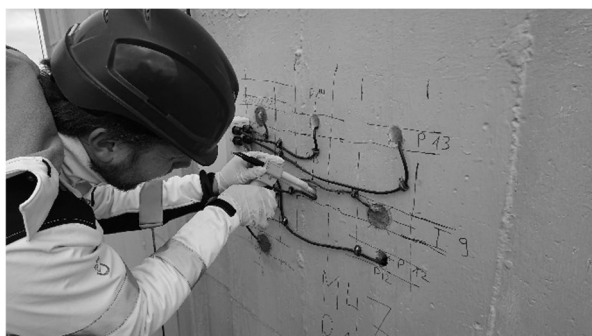
Fig. 7. Injection of a polymer sensor.

The installation of the sensors was carried out from work platforms. Figure 7 shows an example of the injection of a polymer sensor. All cable connections were pre-configured on the sensor side and routed into distribution boxes, where they were shortened and connected to a multi-core cable. This cable was then guided along a wind rib to the upper platform of the tower. Since later access for maintenance on the outer shell is not possible, all active components were to be mounted at an easily accessible location on the upper platform, which can be reached at any time via a staircase.

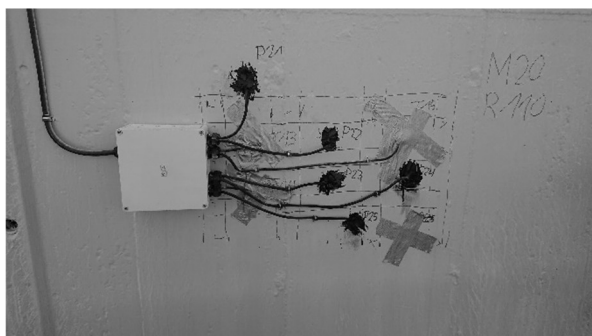
Fig. 8. Measurement field M20/R110 after sensor application.

A representative impression of a completed measurement field is shown in Figure 8.

The injection holes of the polymer sensors were widened in the head area using a drill before injection and sealed after application with a UV-resistant sealant based on PU. This is intended to prevent moisture from entering through the damaged area of the coating and to ensure the corrosion protection of the cable connection from the sensor to the copper cable. The adhesive tape, as shown in Figure 8, was meant to prevent the embedded supplementary cathodes from drying out too quickly, as there was not enough time at each measurement point for proper post-treatment.

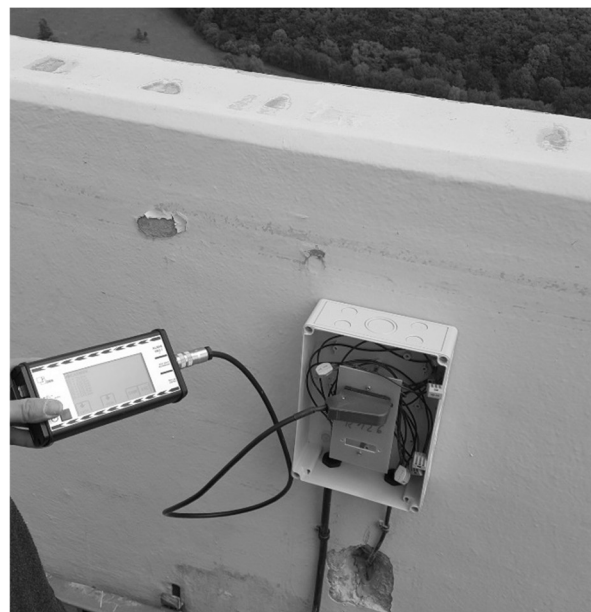
Fig. 9. Measurement box during the initial measurement.

was blocked by the upper carriages and the scaffolding rail system. For this reason, the completion and commissioning could only take place during the next maintenance break, approximately 8 months later. For this, measurement boxes were installed on the upper platform, and the cables were connected to pre-configured connectors. Additionally, the reinforcement connections necessary for the measurement, as shown in Figure 1, were created. The initial measurement, carried out before sealing the reinforcement connection, is shown in Figure 9 as an example.
