# Concertgebouw Amsterdam: History of the main hall and its acoustics

## PART 1: The early years: acoustic design and resolution of acoustic difficulties

Pamela CLEMENTS<sup>1</sup>, Martijn VERCAMMEN<sup>2</sup>

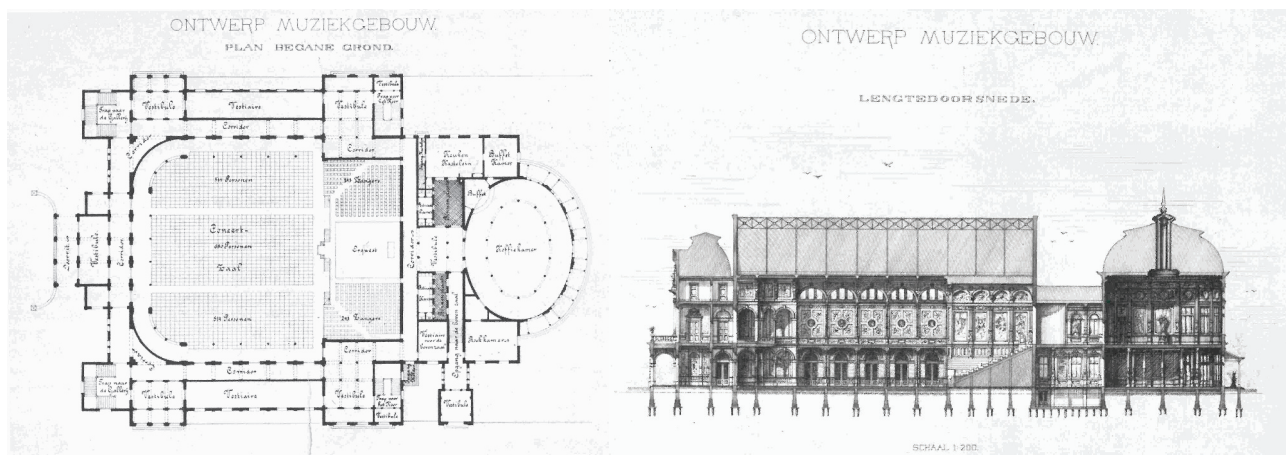
Figure 3. First contest design by Dolf van Gendt, October 1882. Left: plan, Right: longitudinal section

When the five contest designs were evaluated by the jury, it certainly had an opinion on the acoustics. The length and width of the plans were compared to three other shoebox type of halls: Düsseldorf (24x39m), Vienna (19x40m)(note: actually the length at the top is ca. 54 m) and the design of the Gewandhaus in Leipzig (21x42.5m). The main hall in the first design of Dolf van Gendt had dimensions (w<sub>x</sub>l<sub>x</sub>h) 35x42x15,5 m and the jury considered it too wide compared to its length. Another comment was about the flat ceiling, which was considered unfavourable for the acoustics.

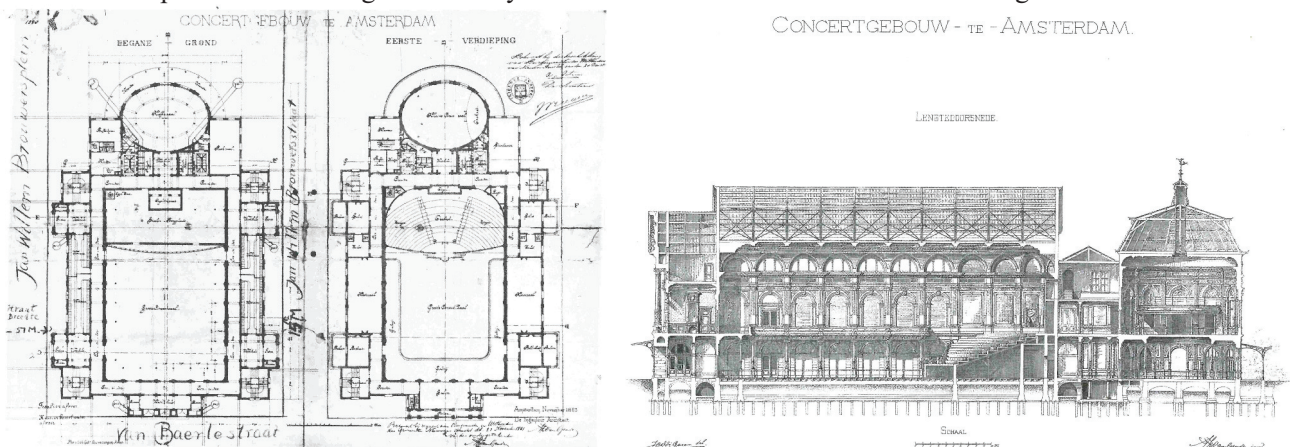
Figure 6. Final design, November 1883

There are other similarities as well: it was a private initiative and a combination of hall and orchestra. However, there is also an important difference: the hall in Leipzig is on the first floor. Shortly after the appointment of Van Gendt in April 1883, he was asked to consider lifting the hall to the first floor to be able to make foyer space and vestiaires on the ground floor. The foundation was considered too heavy for this and it did not fit the budget, so this idea was abandoned. In November 1883 a simplified final design was ready. The two rounded corners behind the stage remained.
