# **Degradation and Defects in Plasma Facing Components for Future Fusion Devices**

Von der Fakultät für Maschinenwesen  
der Rheinisch-Westfälischen Technischen Hochschule Aachen  
zur Erlangung des akademischen Grades einer Doktorin  
der Ingenieurwissenschaften genehmigte Dissertation

**Anna Kapustina**

## **Abstract**

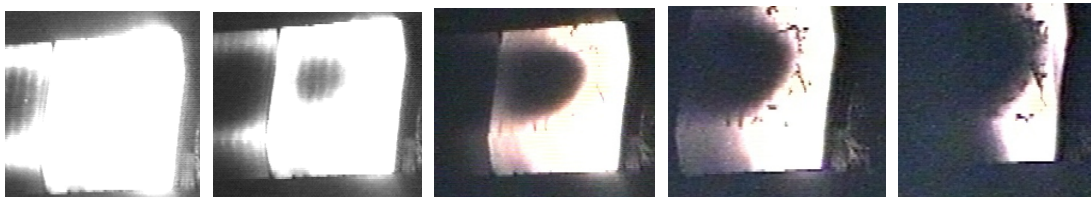
Figure 5.2 - 9. FT 107-3: Cooling down of the tile 1 after switching off the electron beam at  $19 \text{ MW/m}^2$
