# **Effect of Thermal and Mechanical Loadings on the Degradation and Failure Modes of APS TBCs**

**Doktors der Ingenieurwissenschaften**

**Dipl. –Ing. Olena Trunova**

Thermal barrier coatings (TBCs) are applied for the thermal protection of hot section components of gas turbines to improve their life-time or to raise the power and thermal efficiency of the gas turbine by increasing the turbine inlet temperature. TBCs limit the lifetime of the coated component either by spallation or by affecting the surface properties of the component and therefore the fatigue resistance. The respective failure is influenced by a series of degradation parameters and processes such as bond coat oxidation, sintering of the ceramic coating,  $\beta$ -depletion in the bond coat, roughness of the metal/ceramic interface, mismatch of thermal expansion of the coatings and resulting stresses, creep and stress relaxation processes and so forth. These parameters promote the particular damage and failure modes differently and therefore, changes in the complex load scenario during service affect the failure mode and the lifetime of coated components.

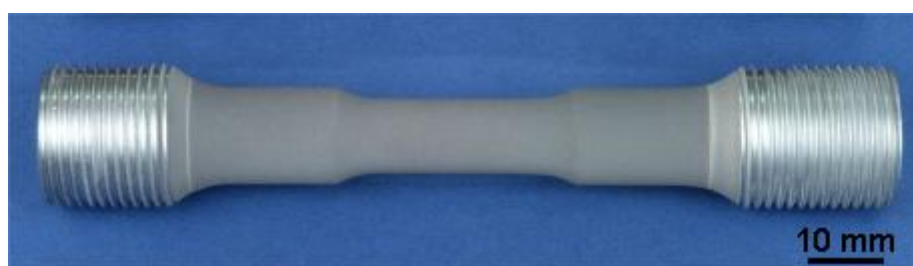
Hollow cylindrical specimens with internal diameter of 6.85 mm and external diameter of 10 mm over the gauge length of 20 mm were used for TMF tests. The geometry of the TBC-coated fatigue specimen is shown in Figure 3.3. Before the tests it was coated with iron oxide to improve absorption of IR radiation.

Figure 3.3 - TMF specimen configuration

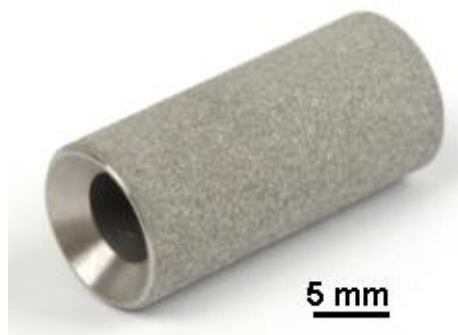
Hollow cylindrical specimens with an internal diameter of 6.85 mm, an external diameter of 8.5 mm and length of 25 mm were used (Figure 3.6).

Figure 3.6 - Specimen configuration for thermal cycling

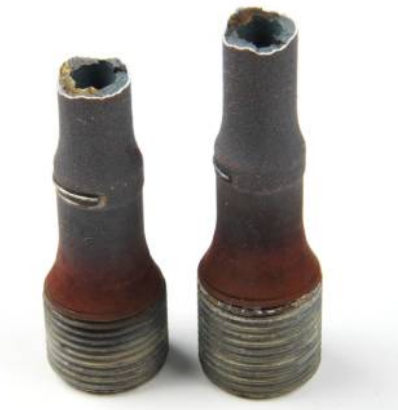
TBC specimens after heat treatments revealed similar behaviour to the non-treated specimen, when the maximum and minimum stresses shifted in the tensile regime during TMF test. Typical tensile stress drop in later stages of testing occurred for all pre-oxidised specimens, indicating fatigue failure of the base material. An example of the failure mode after OP TMF test for specimen pre-oxidized for 300 hours is shown in Figure 5.43

Figure 5.43 – Failure mode of TBC specimen pre-oxidized for 300 hours after OP TMF with mechanical strain range of 0.6% and temperature range of 350-1050°C

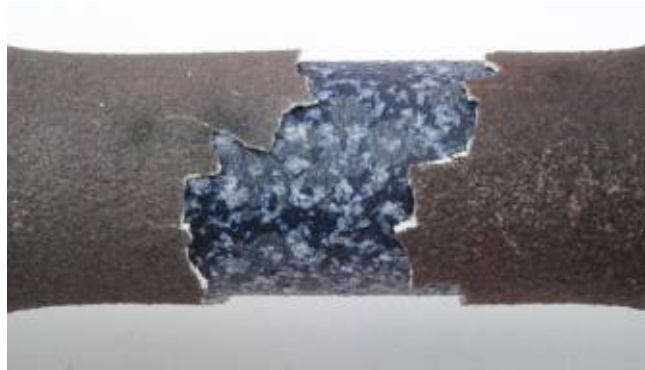
In contrast to TMF tests without a dwell time, the failure occurred by TBC spallation before fatigue cracking of base material, therefore no reduction was observed in the stress level. Failure occurred after 620 cycles for TMF with a strain range of 0.6% and 1638 cycles with a strain range of 0.3%. This corresponded to 1240 and 3276 hours of high temperature exposure, respectively. An example of TBC spallation after TMF with 0.6 % strain is shown in Figure 5.49.

Figure 5.49 - Spallation of TBC after OP TMF with dwell time at high temperature in temperature range of 350-1050°C and mechanical strain range of 0.6 %

Taking into account data obtained for the cyclic oxidation of TBC in the same time-temperature cycle between 350 and 1050°C (see section 5.3.3.2) i.e. TMF with 0 % mechanical strain, it is clear that cyclic mechanical strain of 0.6 % led to a decrease of more than a factor of two in TBC lifetime.

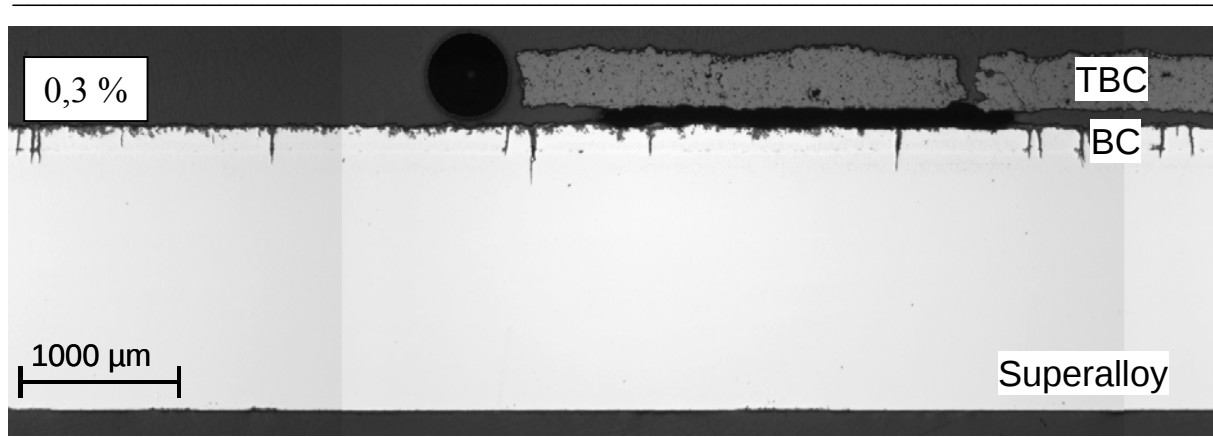
(b)

Examination of the cross-sections after OP TMF with dwell time (Figure 5.50) showed the presence of fatigue cracks in BC. The crack density also decreased with decreasing strain range. Almost all cracks were of a similar length and stopped at the BC/superalloy interface.

Figure 5.50 - Overview of the crack propagation within the TBC system under OP TMF with a dwell time and temperature range of 350-1050°C: a) mechanical strain range of 0.6%, b) mechanical strain range of 0.3%
