# Edge fracture of the first and third-generation high-strength steels: DP1000 and QP1000

Z Li<sup>1</sup>, Y Chang<sup>2</sup>, J Rong<sup>1</sup>, J Min<sup>3</sup> and J Lian<sup>1\*</sup>

**Abstract.** Advanced high-strength steels (AHSS) have shown profound progress in improving tensile ductility or global formability in the last decades over three generations. For a complete assessment of both the global and local formability, this study aims to characterize and compare the tensile and edge fracture behavior of the first and third-generation AHSS (dual-phase steel and quenching & partitioning steel) with the same nominal strength level of 980 MPa. Uniaxial tensile tests are performed to characterize the tensile properties. Hole expansion tests are conducted with two edge conditions based on separated preparation techniques (waterjet with polishing and punching) to investigate the edge fracture for both materials. The hole expansion ratios and edge fractures are compared between two materials and two edge conditions. It is concluded that the investigated QP1000 has promoted global formability while the DP1000 shows better local formability due to its damage-tolerant and crac

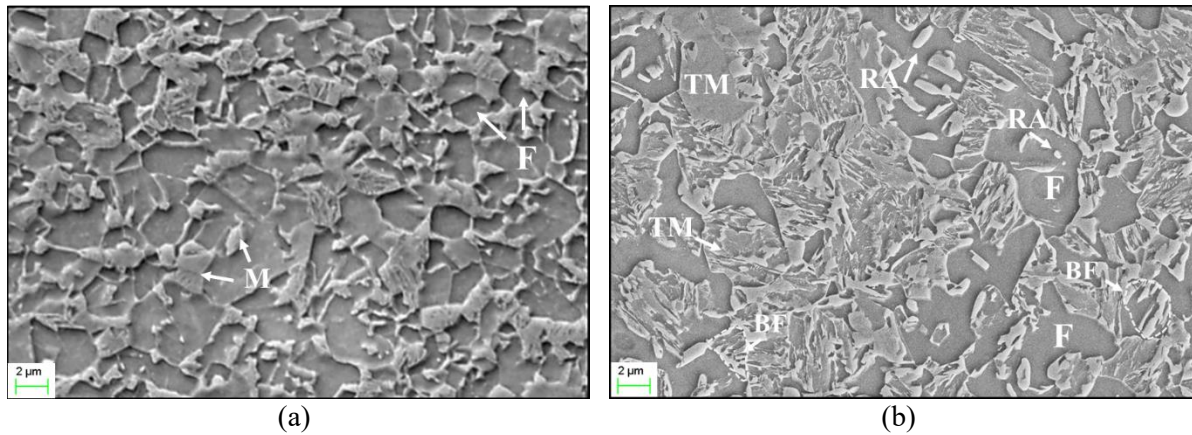
**Figure 1.** Microstructure of (a) DP1000 [24] with martensite (M) and ferrite (F) phases indicated, and (b) QP1000 with retained austenite (RA), tempered martensite (TM), bainitic ferrite (BF) phases indicated.

The sheet metals chosen for this study are as-received high-strength DP steel (DP1000) with a measured thickness of 1.46 mm and quenching & partitioning steel (QP1000) with a thickness of 1.36 mm. The chemical composition of the DP1000 and QP1000 material is performed via a BELEC LAB 3000s optical emission spectrometer. The analysis results are summarized in Table 1. The microstructure was obtained from scanning electron microscopy (SEM). The micrographs of both materials are shown in Figure 1. DP1000 is composed of ferrite and martensite phases, with an approximate martensite phase fraction of 45% [23]. QP1000 contains metastable retained austenite (RA), tempered martensite, secondary martensite, as well as non-martensitic constituents (NMC) such as bainitic ferrite apart from ferrite.

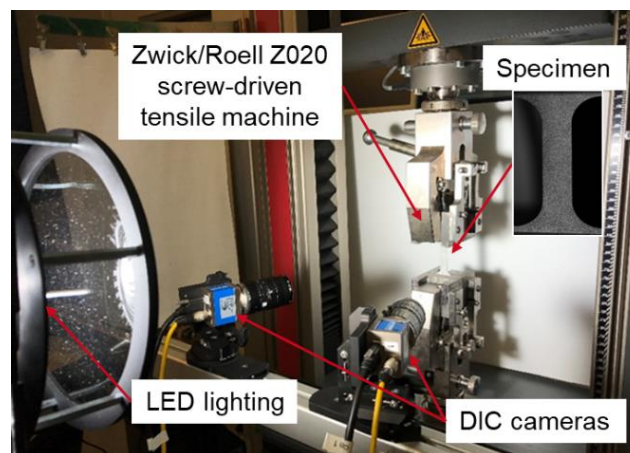
**Figure 2.** Uniaxial tensile testing set-up with stereo-DIC system and lighting.

The tensile properties were tested using a Zwick/Roell Z020 screw-driven tensile machine. Uniaxial tensile tests of the smooth dog-bone (SDB) specimens were performed at room temperature (RT, 25°C) under quasi-static (QS,  $10^{-4} \text{ s}^{-1}$ ) loading along rolling direction (RD). The testing setup is shown in Figure 2. A stereo digital image correlation (DIC) system was used to measure the displacement during the deformation, with the detecting camera resolution of 50 pixels/mm. To ensure the image quality, the surface of the specimen was lacquered with an even layer of white paint and then sprayed to form speckle patterns with a speckle diameter of 5-10 pixels. A parallel filter was placed before the spotlight, which can minimize the reflections from the material surface and therefore, improve the lighting condition.

Observations were recorded from Hikvision cameras with two separate signals (Left-0, Right-1) from both sides.

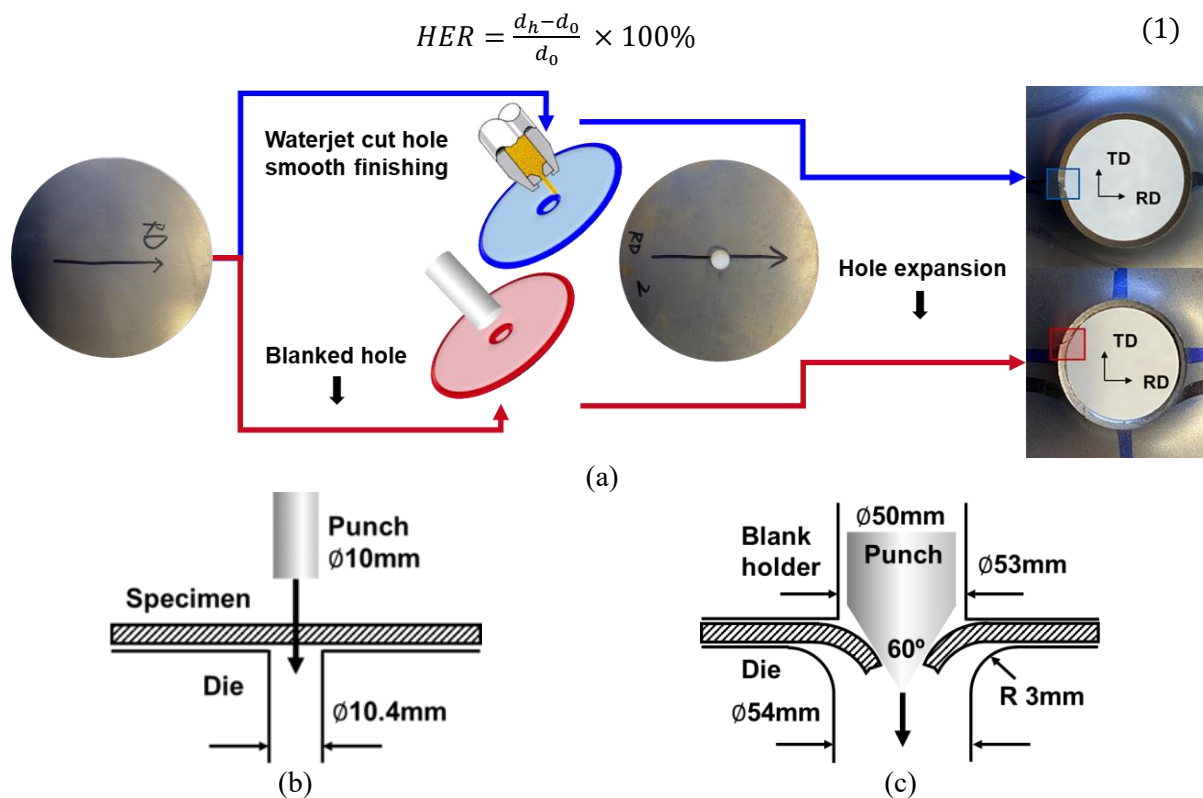
**Figure 3.** Schematic diagram of (a) the edge fracture characterization approach, (b) cross-section view of the hole blanking, and (c) cross-section view of the hole expansion process.

To characterize the edge fracture, circular specimens with a diameter of 90 mm were cut as shown in Figure 3 (a). Central holes with separated edge conditions were prepared based on different manufacturing techniques. The smooth edge condition was introduced by waterjet cutting and then ground to 10 mm with a smooth finish. The blanked hole is punched from the hole blanking process as schematically illustrated in Figure 3 (b). Then these two materials under both edge conditions were conducted in the HET following the ISO/16630:2017-09 standard. The set-up of the HET is depicted in Figure 3 (c). The specimen was clamped in between the die and blank holder under a holding force of 235 kN. Then the specimen was expanded by a conical punch at a 5 mm/min expansion speed until the first through-thickness crack (1<sup>st</sup> TTC) was detected on the edge of the hole. The tracking of the first through-thickness crack easily got overshoot with bare eyes. Therefore, a camera was introduced to record the images and observe the deformation at each frame. The hole expansion ratio (HER), as a criterion to characterize the resistance to edge fracture, was then calculated as defined in Eq. (1), where  $d_h$  is the inner hole diameter after expansion and  $d_0$  is the original hole diameter before the test. Both were measured by digital caliper and averaged across three repeats. The results after expansion were further verified with the measured values from the images captured by the camera, to make sure the diameters were taken at the exact time when the first through-thickness crack occurred.

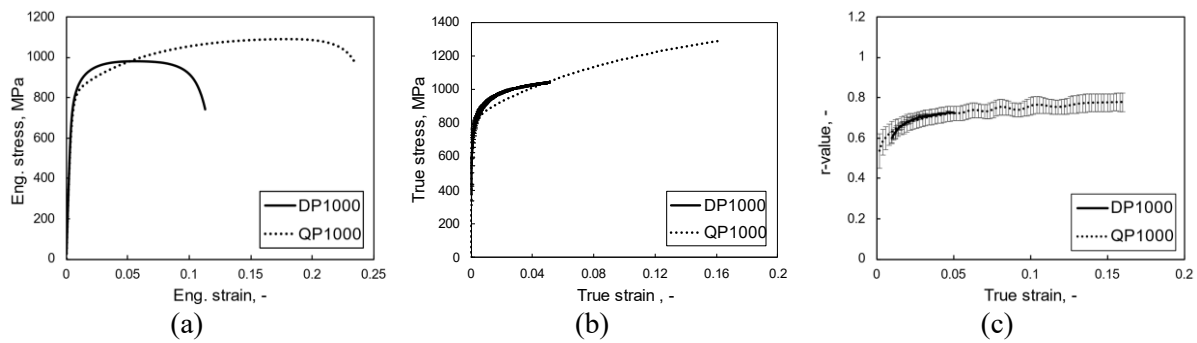
**Figure 4.** The tensile properties from uniaxial tensile tests, (a) engineering stress-strain curves, (b) true stress-strain curves, and (c) r-value curves of QP1000 in comparison with DP1000.

The engineering stress-strain, true stress-strain, r-value, and forming limit curves from the uniaxial tensile tests along RD for both materials are shown in Figure 4. The mechanical properties of the DP and QP steels such as yield strength (YS), ultimate tensile strength (UTS), percentage uniform elongation (% UE), percentage total elongation (% TE), and Lankford coefficients (r-value) at UE are listed in Table 2. DP1000 shows a slightly higher YS value, while QP1000 surpasses UTS. From the results, QP1000 reaches yield strength sooner before DP1000, while it takes much longer elongation to reach UTS and then to fracture. The UTS is improved by 10% from DP1000 to QP1000. What is significantly enhanced is the ductility, the UE of QP1000 is more than three times higher than the one in DP1000, and the fracture elongation is also increased by more than 100%. There is no significant difference between the two materials in terms of the r-value and their evolution pattern. Further investigation can be made by taking into account the loading effect for the anisotropic properties, Further investigation can be made by taking into account the loading effect for the anisotropic properties, which can be found in detail in a follow-up study [25].

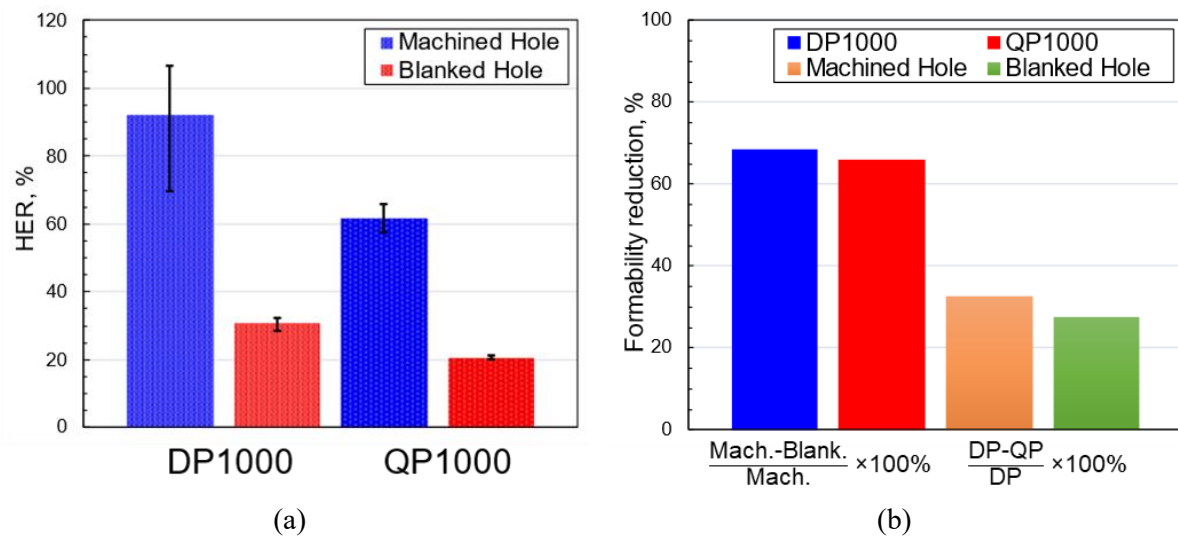
**Figure 5.** HER values analysis (a) of the punched and machined holes for DP1000 and QP1000, (b) the formability reduction from smooth edge to punched edge for each material, and from DP1000 to QP1000 for each edge condition.

**3.2.1. HER.** The HER values for the blanked and machined holes of DP1000 and QP1000 are compared in Figure 5 (a). Sensitivity to the edge condition for both materials was characterized by comparing the HER on each condition. Both steels demonstrate strong sensitivity to the edge condition. The HER value for DP1000 is higher than QP1000 for both conditions, i.e., DP1000 shows higher edge fracture resistance than QP1000. For the DP1000 machined hole, the HER is 92%, which is almost one and a half times the value measured for the machined hole of QP1000, 62%. A similar trend exists for the blanked hole of DP1000, which has an HER of 29%, while the HER for the blanked hole of QP1000 is 21%, giving a slightly reduced difference in between. The confidence interval has a rather small value for the blanked holes, suggesting there is no significant variation for the pre-damage introduced to the blanked edges. Whereas the error for machined holes is comparatively high, which indicates the ideal smooth condition can be easily breached, adding up the fact that it is often difficult to accurately track down the moment when the first through-thickness crack is forming. The measured HER includes error from overshoot of the punch head. As shown in Figure 5 (b) with the blue and red bars, both materials can be clearly differentiated between the edge conditions with formability reductions of 66-68%. The variations for machined holes in DP1000 are larger than in QP1000 due to the fact that the specimen preparation process is slightly different, with QP1000 cut directly from electrical discharge machining (EDM) with higher surface quality. The formability reduction for DP1000 is slightly higher than in QP1000 can be explained by the study [26] that for blanked edges, a higher density of voids can be found at ferrite-martensite interfaces. The excellent damage tolerance and crack resistance of DP1000 got depressed, making it more vulnerable to fracture. The formability distinguishes between QP1000 and DP1000 are around 27% for smooth edges as shown in a green bar, and 33% for blanked edges plotted in an orange bar.

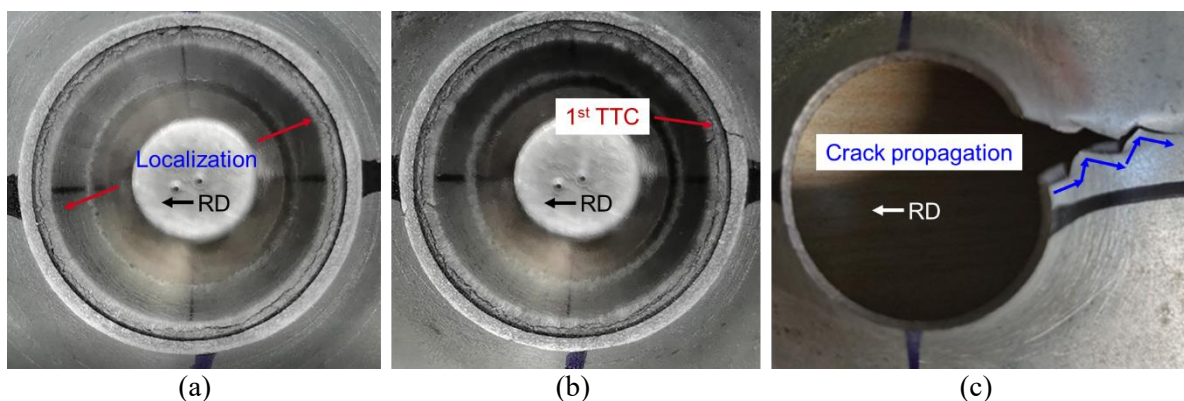
**Figure 6.** Edge fracture pattern and locations on smooth edges for DP1000 (a) after strong localization, (b) the moment when the first through-thickness crack occurs, and (c) crack propagation with blue marks.

**3.2.2. Edge fracture on smooth holes.** The edge crack distribution and pattern for DP1000 and QP1000 on smooth holes are shown in Figure 6 and Figure 7, respectively. The localized necking is clearly observed at the hole edge close to RD in DP1000 as marked in Figure 6 (a), whereas no obvious thickness reduction can be found on the hole circumference for QP1000. As shown in Figure 6 (b), the first through-thickness crack locates near RD, with fractures prone to a slant angle of conical punch during deformation, then rapidly propagating through the thickness to form the first major crack. If the test is not halted immediately, the crack would expand further in the radial direction following a serrated path as sketched in Figure 6 (c). For QP1000, after the first major crack, a limited number of minor cracks can be observed initiating from the bottom layer, as blue triangles annotated in Figure 7. One out of all the minor cracks can also develop further to form another through-thickness crack, whereas the same behavior is not observed on DP1000. Fracture is prone to develop into one or at most two major cracks in the smooth edge region for both materials.

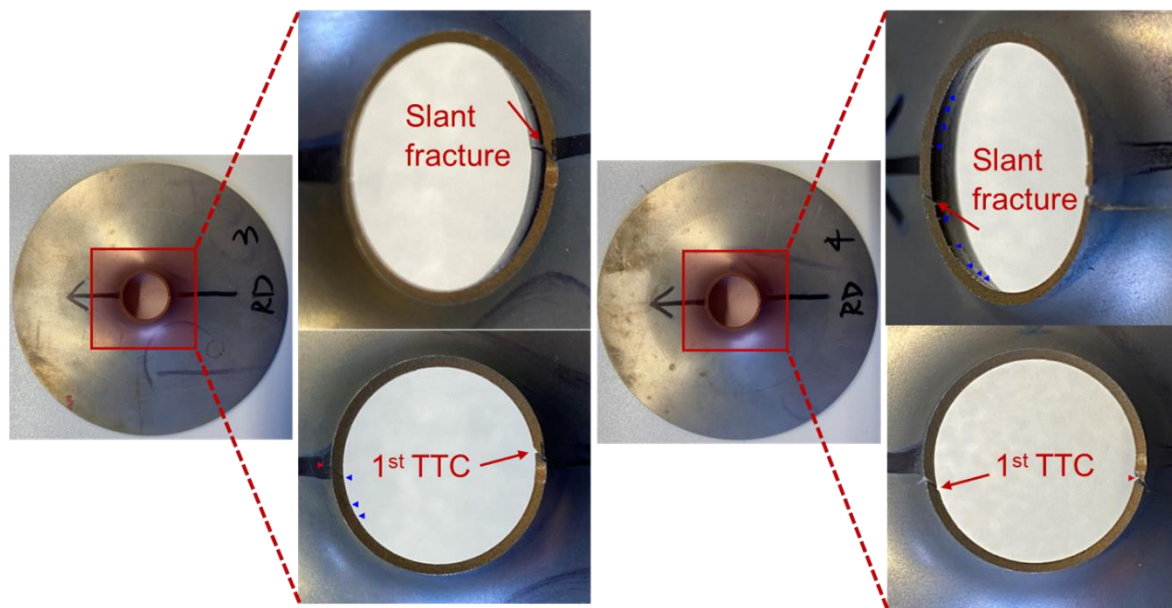
**Figure 7.** Edge fracture pattern and locations on smooth edges for QP1000 after first through-thickness crack, and blue marks for minor cracks.

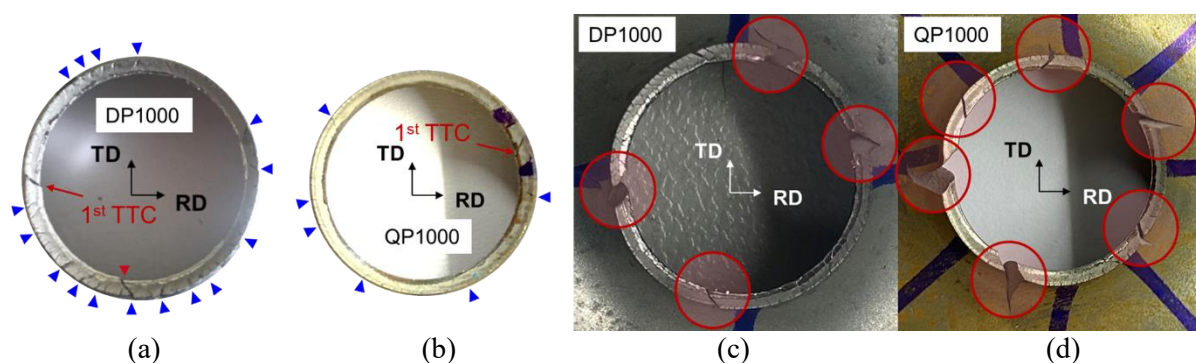
**Figure 8.** Edge fracture pattern and locations on blanked edges for (a) DP1000 and (b) QP1000 with blue marks for minor cracks, (c) further expanded with four major cracks at the punched edge of DP1000, and (d) QP1000.

**3.2.3. Edge fracture on punched holes.** The edge crack distribution and pattern for DP1000 and QP1000 on punched holes are shown in Figure 8 (a) and (b), respectively. No noticeable localization can be witnessed for either material. The first through-thickness crack has the same location close to RD as in smooth edges, while the fractures were prone to a slant angle of  $45^\circ$ . Different from the pattern on the smooth edge, the crack initiates not only from the bottom layer but also from the top surface of the punched hole. The number of minor cracks on punched edges is distinctively larger than in the smooth condition for both materials, while DP1000 collects more minor cracks than QP1000. When the force is applied continuously after the first major crack appears, the hole gets expanded further. For DP1000, the number of major cracks grows to four. The location of these four major cracks at the open-up circumference is along RD and transverse direction (TD), as marked with red circles in Figure 8 (c). For QP1000, the number of major cracks ended into six as shown in Figure 8 (d). The locations are not only at RD, and TD but also along the diagonal direction (DD).

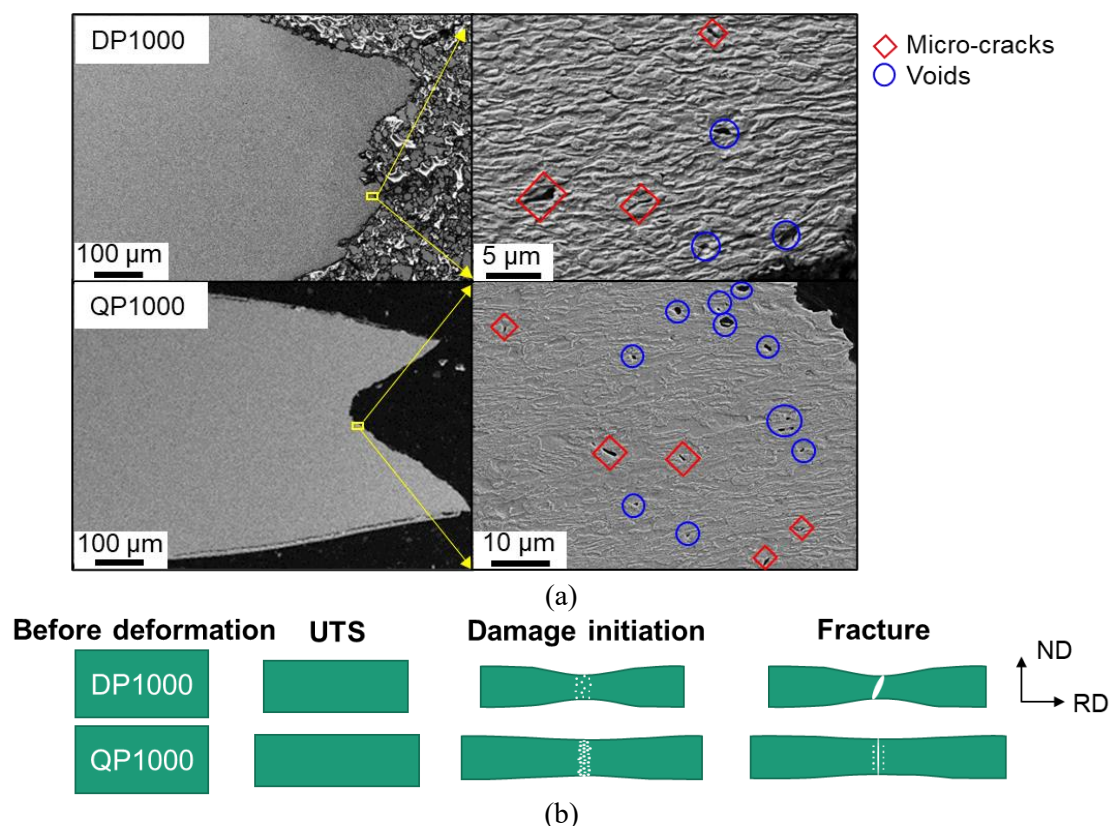
**Figure 9.** Microstructure-level damage mechanism analysis: (a) SEM fractography of fractured specimens with the red and blue indicators pointing out the micro-cracks and voids, respectively, and (b) schematic drawing of the relationship pattern during uniaxial tension for DP1000 and QP1000.

The SEM fractography of the local critical area in the section close to the fracture surface after uniaxial tensile tests are shown in Figure 9 (a), with the red quadrilaterals and blue circles indicating micro-

cracks and voids, respectively. The number of defects, in terms of voids and micro-cracks, is distinctively larger in QP1000 than in DP1000, especially for voids. It is noticeable that both ferrite and martensite grains are extremely elongated in the severe deformation zone in DP1000, as previously reported [27]. For DP steels, three void nucleation damage mechanism modes including martensite brittle cracking, ferrite-martensite interface decohesion, and ferrite-ferrite grain boundary decohesion are commonly found. Since both phases are relatively fine microstructures, it is difficult to distinguish between microcracks and voids from the phase boundaries. However, as the ferrite phase shows generally higher ductility and deformed more easily compared to martensite, phase boundary debonding is the main failure type under tensile loading at room temperature [27], while for higher temperatures, more complex damage mechanisms take place due to dynamic strain aging effects [28]. The current investigated QP grade contains both tempered martensite and secondary martensite, arising the fraction of the harder and more brittle phases in general. In addition, the interaction between RA and martensite in QP steels exacerbates the occurrence of phase boundary debonding during uniaxial tension, leading to the formation of voids and cracks more easily to reach rupture.

The deformation history of both materials, including the plastic localization, damage initiation, and fracture can be found in the schematic drawing from Figure 9 (b). QP1000 shows a higher uniform deformation strain than DP1000. DP1000 yields a large amount of plastic localization before damage occurs followed by a fast damage evolution stage until the final fracture. While QP steels exhibit low resistance to fracture due to their sensitivity to damage development, resulting in lower local formability. In DP1000, damage concentrates on localized regions. QP1000 on the other hand has a more homogeneous deformation with more uniformly distributed damage. However, with a larger amount of voids and micro-cracks, the rather uniform deformation and uniform damage distribution lead to a sudden fracture with the cracks growing along. In contrast, the high level of strain localization and corresponding concentrated damage of DP1000 leads to a fracture pattern with significant necking.
