# Structural damage, clogging, collapsing: Analysis of the bridge damage at the rivers Ahr, Inde and Vicht caused by the flood of 2021

Institute of Hydraulic Engineering and Water Resources Management, RWTH-Aachen University, Aachen, Germany

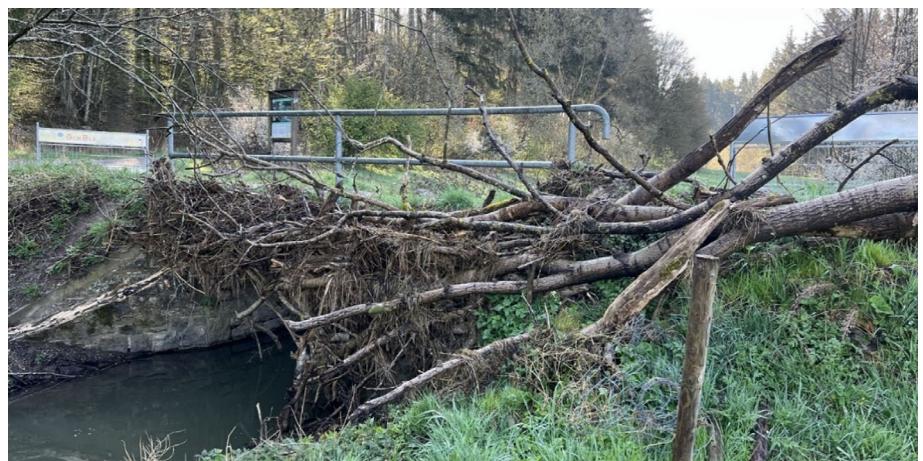
**FIGURE 2** Exemplary photo of a bridge in the upper reaches that showed indication of clogging during the flood event (own figure).

In addition, the runoff patterns and hydraulic conditions at the bridge locations during the July 2021 flood event were observed, if possible. Therefore, water levels, and thus the water level right in front of the bridge, were estimated using flood marks and the extent of the floodplain provided by the state offices for environment RLP and NRW. With the help of aerial photographs and flotsam residue on the bridges and surrounding area, it was estimated whether clogging at the bridge occurred, as well as the degree of clogging (see Figure 2). Thus, flotsam residue on the bridge railing and on trees at the level of or above the bridge deck directly adjacent to the bridge were considered to be indicators of clogging.

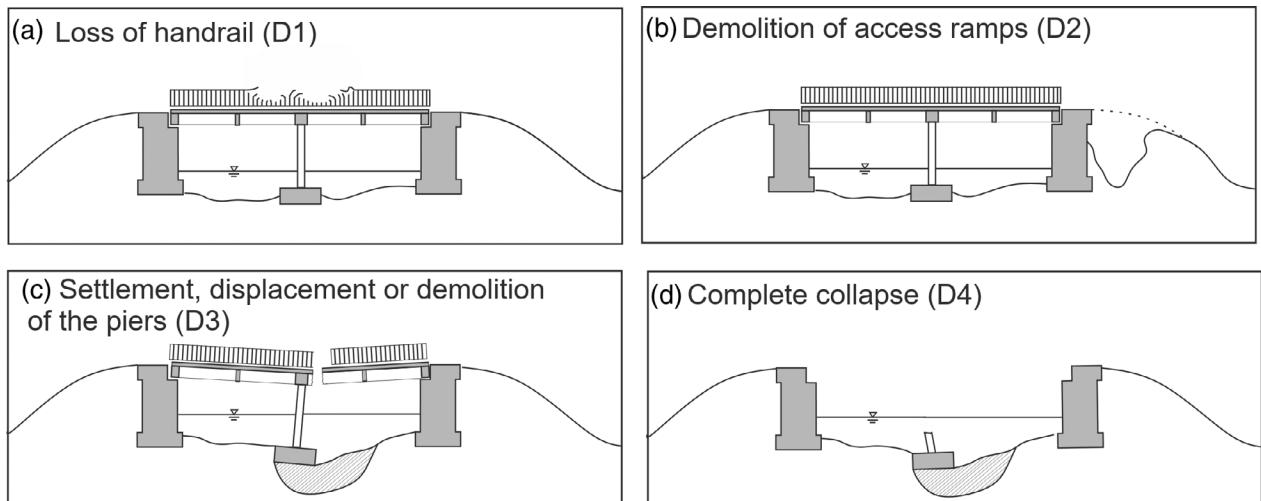
FIGURE 3 Exemplary schemes for the different bridge damages observed after the flood event 2021 (own figure).

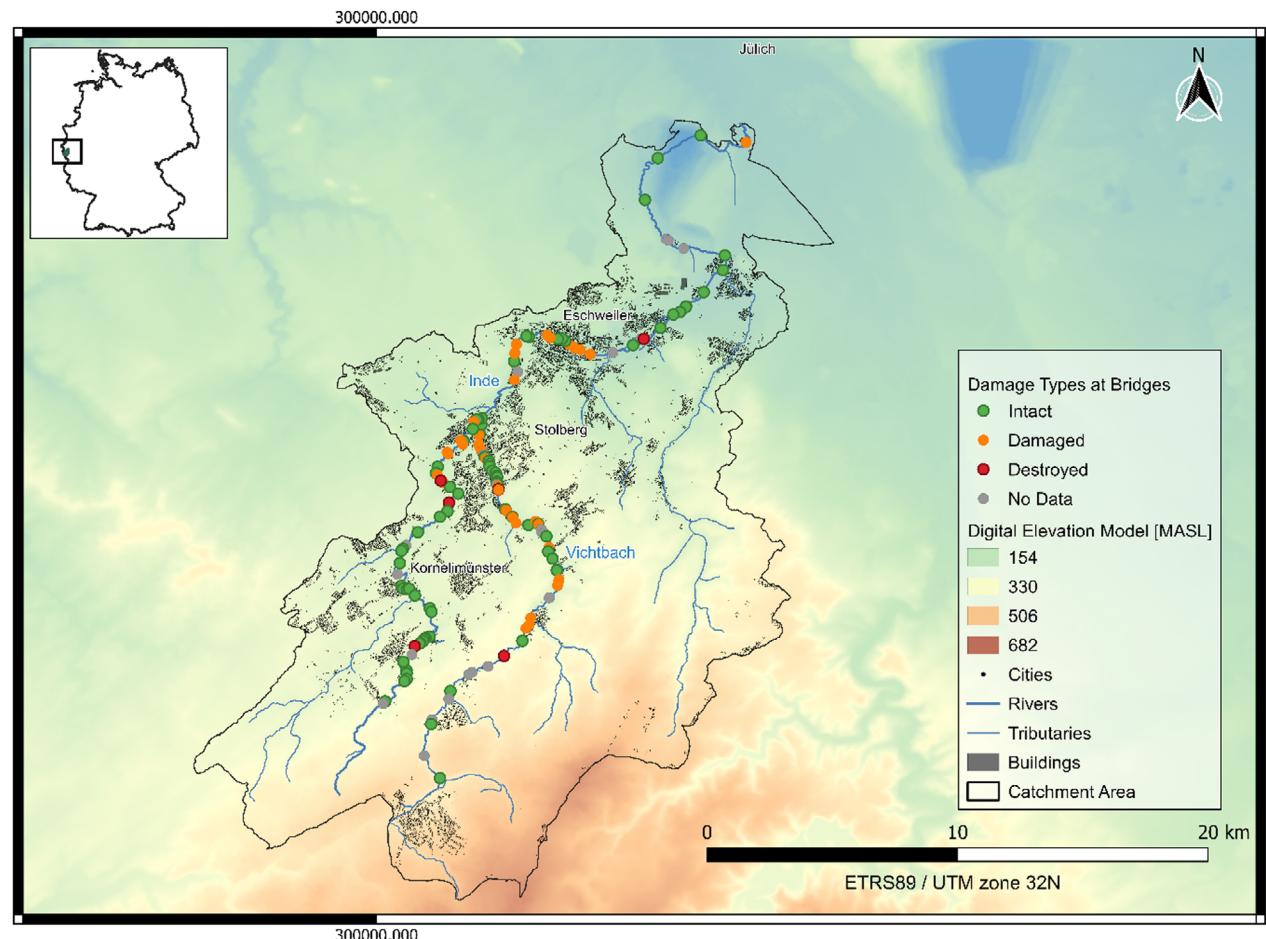
In total, 32% of the 77 analyzed bridges along the river Inde were damaged or destroyed due to the flood event in 2021, meaning that those bridges were classified between the damage classes D1 and D4 (see Figure 4). Damages in the category D1 made up the largest proportion of bridge damages while the bridges were distributed similarly across the other classes. Most damaged bridges were located in the urban areas of Eschweiler and Stolberg, where the bridge density is highest. It was possible to document the damage classes for 52 of the bridges

FIGURE 4 Damage mapping of the bridges at the rivers Inde and Vicht affected by the flood 2021 (own figure).

along the river Vicht. Half of the bridges were categorized as damage class D0. This is followed by 23 bridges with damage class D1. One bridge was assigned to damage class D2, no bridge to damage class D3 and two bridges to damage class D4. Most damaged bridges were located in the urban areas of Stolberg and Zweifall along the river Vicht. The proportion of bridges damaged in urban areas is more than three times higher than the proportion of bridges damaged in rural areas.

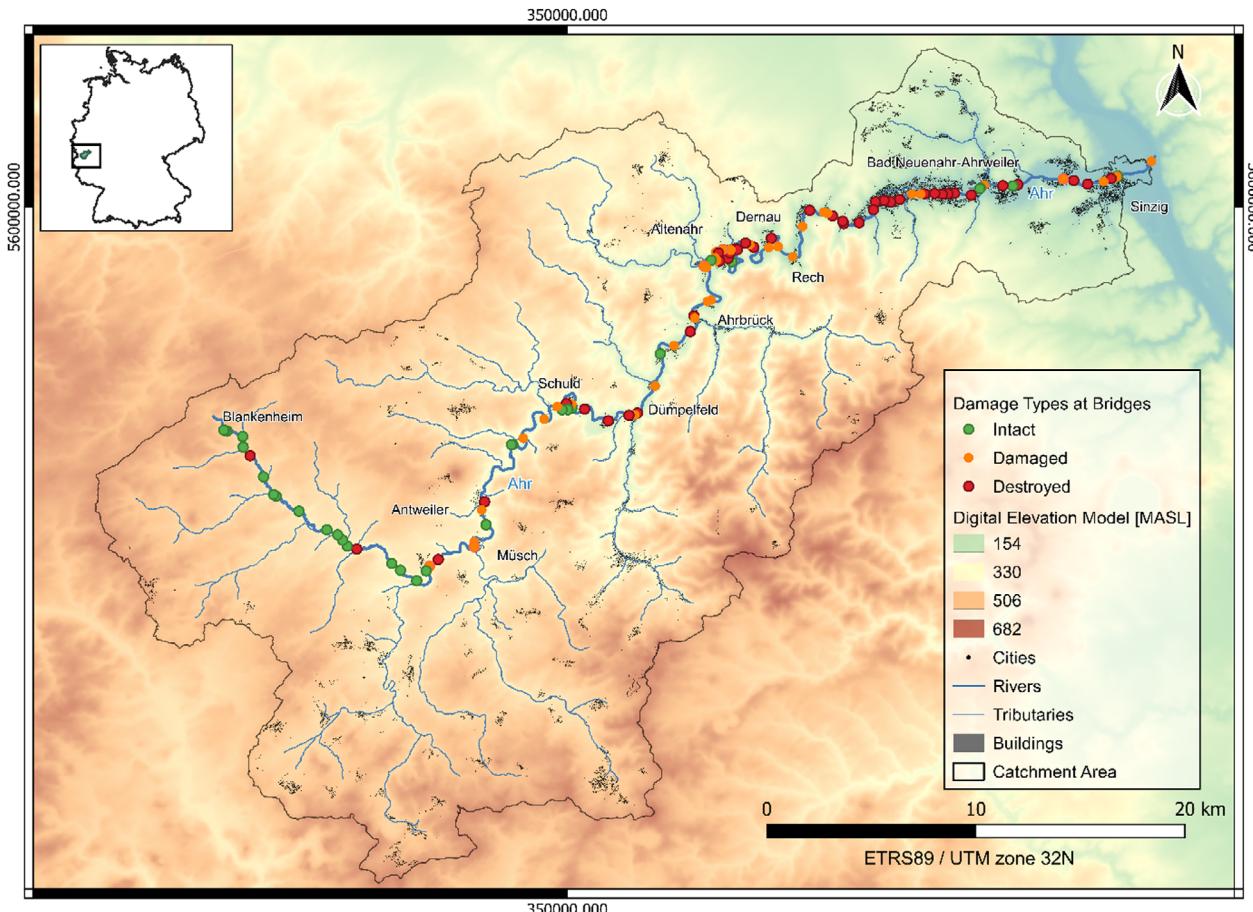
In comparison to the rivers Inde and Vicht, bridges along the river Ahr suffered more damage, with larger proportions of bridges within the categories D1 till D4. About three quarters of the 114 bridges along the Ahr were categorized as damaged (see Figure 5). Of these, about 41 of the bridges were destroyed and the rest damaged. In the upper reaches of the Ahr between Blankenheim and Dorsel in NRW, only two of the 20 bridges suffered damage in the course of the flood (see Figure 6). In the middle reaches of the Ahr, ~90% of the bridges were damaged, in the lower reaches ~85%. Along the rivers Ahr and Inde, the proportion of damaged bridges within populated areas is more than twice as high as in

FIGURE 5 Damage mapping of the bridges at the river Ahr affected by the flood (own figure).

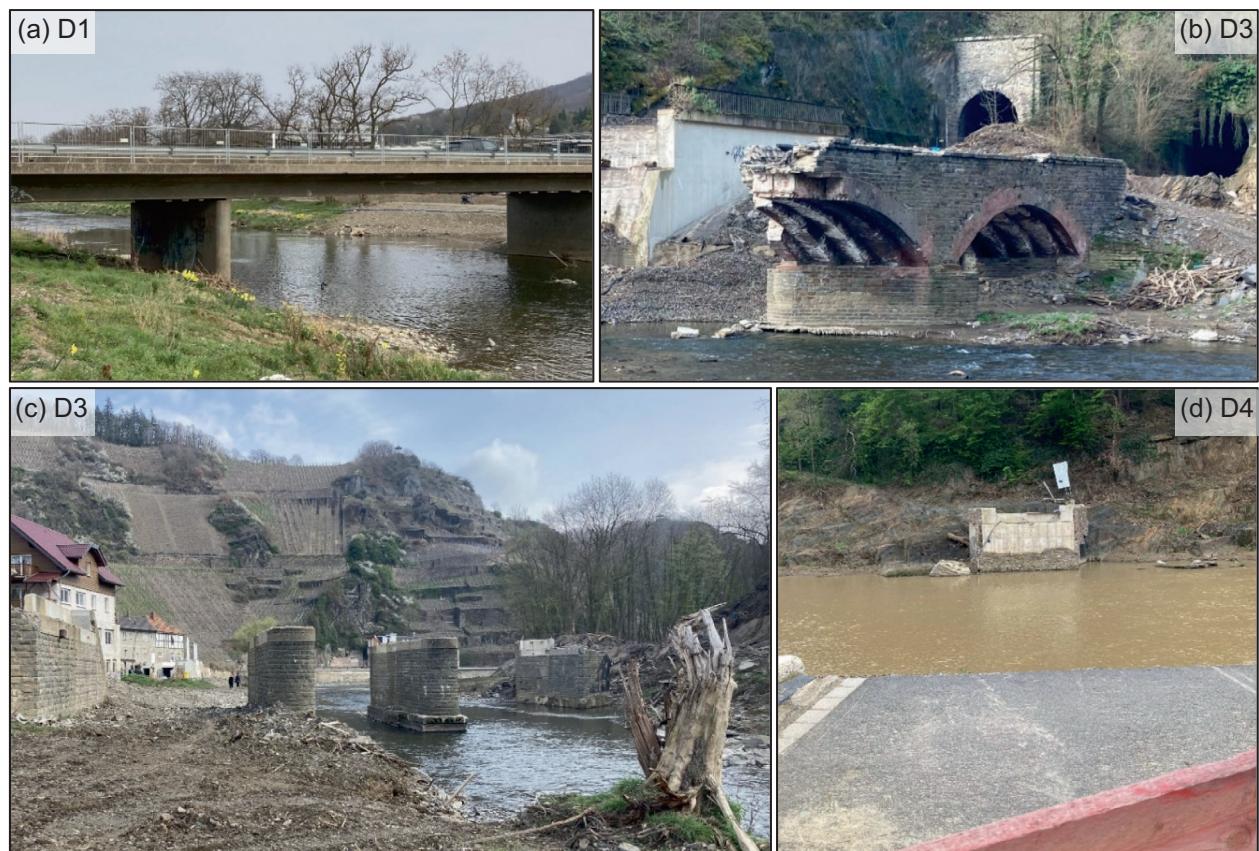
**FIGURE 6** Documentation of different damage classes along the river Ahr: (a) loss of handrail, (b) large scale removal of building fabric, (c) loss of the superstructure, and (d) complete collapse (own figures).

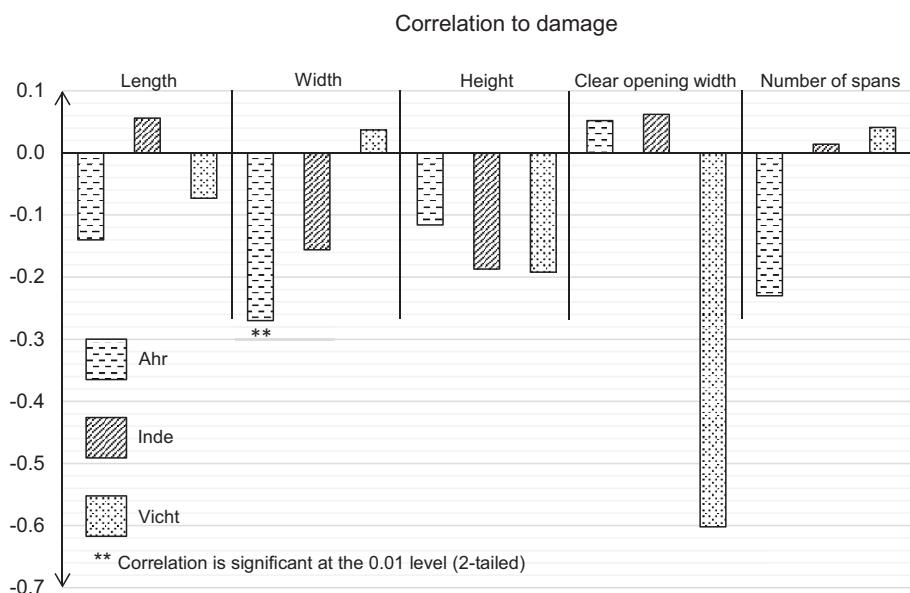
the rivers Vicht and Ahr, a slightly lower positive correlation was determined for the river Inde. The negative correlation would indicate, that longer bridges would be less prone to bridge damage during floods. Between the width of a bridge and the occurred damage, a significant negative correlation of  $-0.27$  at the 0.01 level was determined for bridges along the Ahr. Here, the results for the rivers Inde and Vicht are opposed with a slight positive correlation of 0.03 along the Vicht and a slight negative correlation of  $-0.16$  for the river Inde. Along all three rivers, a slightly negative correlation of up to  $-0.19$  was determined for the bridges regarding the height of the bridge and the extent of damage. This is the only correlation that matches along all three rivers and reaches a level higher than 0.1. While the level of correlation is still weak, it indicates that a lower extent of damage on a bridge could result with a higher bridge deck.

Regarding the clear opening width, bridges along the rivers Inde and Ahr showed slightly positive correlations of around 0.06 with the extent of damage. The result for the river Vicht differed strongly with a negative correlation of  $-0.60$ , indicating that the extent of damage decreased with an increasing opening width. While the

correlation coefficient for the rivers Inde and Vicht showed a positive trend up to 0.04 regarding the number of spans and the damage classes, a stronger negative correlation of  $-0.23$  was derived for the bridges along the river Ahr. This suggests on the contrary, that the extent of damage would have decreased with an increasing number of bridge piers. For the shape of the opening no statistical correlation could be observed along the three rivers since bridges with a rectangular opening were more dominant along the rivers Inde and Vicht and therefore no representative distribution was derived. Regarding the year of construction and the degree of bridge damage, no significant correlation could be determined. Along the rivers Inde and Ahr, it was observed that pedestrian bridges and lightweight constructions for hiking and bicycle bridges suffered damage to a larger extent.

**FIGURE 7** Summarizing correlation analysis regarding the bridge design characteristics and damage (own figure).

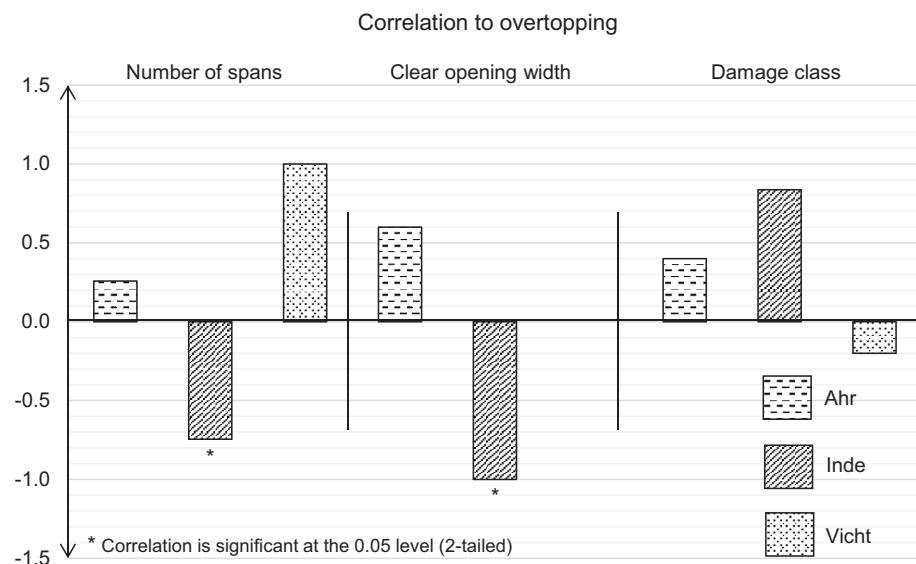
Furthermore, the correlation between bridge design and the overtopping and clogging of bridges during the flood event was analyzed. Overtopping of bridges (whether induced by clogging or not) resulted in major bridge damages but also damages to the surrounding area. Again, the statistical correlations between all three

**FIGURE 8** Summarizing correlation analysis regarding the bridge design characteristics and overtopping (own figure).

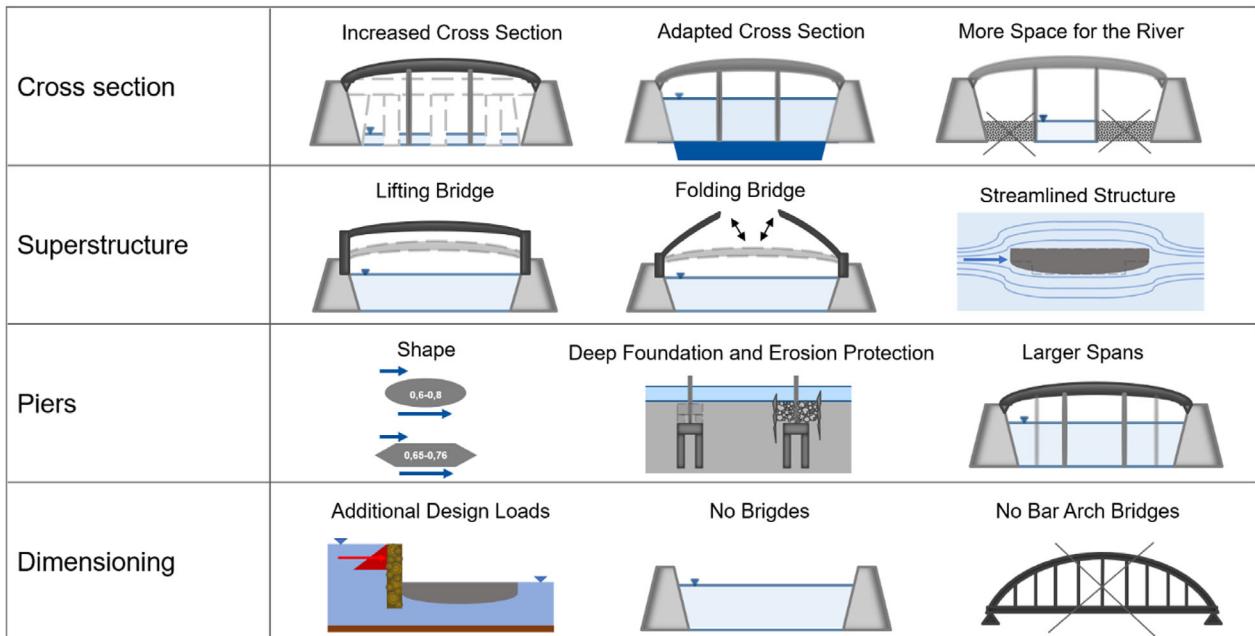
FIGURE 9 Recommendations for flood-adapted bridges (own figure).

study as well as previous studies (see Figure 9). These include adaptations in the cross section, the superstructure, the piers, and the dimensioning processes. With the help of these changes, the probability of clogging as well as the hydraulic backwater rise can be reduced, overall increasing the resistance of the structure against hydraulic stresses (Jempson, 2000; Patt & Jüpner, 2020).

The size of the cross section was determined to be an important factor for the extent of damage, clogging, and overtopping of a bridge during this analysis. In order to increase the clear bridge opening, the superstructure of the bridges should be raised and more flow cross-section as well as a higher freeboard should be guaranteed (Gschnitzer et al., 2017; Zevenbergen et al., 2012). Additionally, larger span widths should be achieved in the design of new bridges, thus reducing the number of bridge spans and piers (Gschnitzer et al., 2017; Rutschmann, 2017). Abutments should be located outside the flow cross-section with appropriate protection from erosion (Deutsches Institut für Normung e. V., 1998; Pohl, 2015). At the same time, as far as technically possible, small bar arch construction methods should be dispensed with. Although these can increase the span widths, they have an increased raking effect for flotsam due to the superstructure. In the event of flooding with water levels at the bridge deck and the accumulation of flotsam, this increases the loads on the bridge structure and carries the risk of the structure being torn down. In addition, the bridge superstructures should be designed as narrow as possible, making its geometry favorable for

flowing water in order to reduce the backwater in front of the bridges and the potential for clogging. (Ahmari et al., 2021; Goedeking & Landvogt, 2022; Greco et al., 2021) Obstructed bridge spans should be kept clear during reconstruction to provide more space for the river to flow and to reduce runoff obstructions. The demolition of approach ramps to bridges is a common damage pattern during the 2021 flood, so the German Committee for Disaster Reduction recommends that approach ramps should be designed to withstand overtopping (Deutsches Komitee Katastrophenversorgung e.V., 2022). This should prevent the damage caused by erosion and maintain the operational capability of the bridges. Further, the implementation of streamlined pier designs and deep foundations as well as erosion control for new bridge structures is recommended (Lamb et al., 2017; Pohl, 2015; Zevenbergen et al., 2012). Loads due to impact of clogging, damming and overtopping, for example, lifting forces and increased debris impact on the slip-off slope, should also be regarded in the new design processes (Jempson, 2000).
