## A case study on fatigue damage in PVD coated tool steel under cyclic bending load

K. Bobzin, C. Kalscheuer, M. Tayyab\*

Surface Engineering Institute, RWTH Aachen University, Kackertstraße 15, 52072 Aachen, Germany

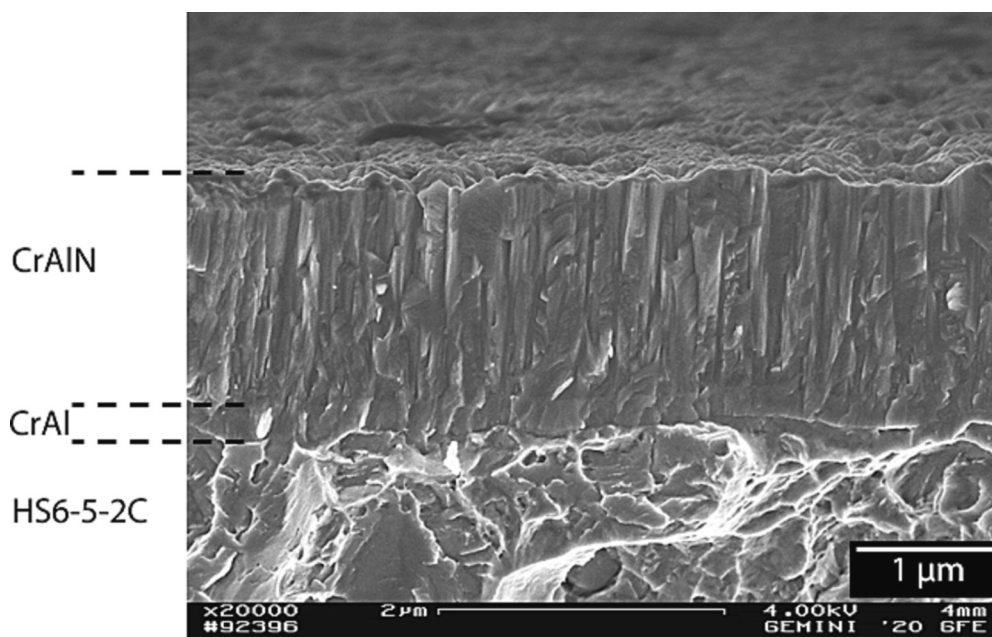
Fig. 1. SEM image of the CrAlN coated compound in cross-section; sample ID 4052 [12].

Prior to coating deposition, the HS6-5-2C substrates were heat treated to achieve a final hardness  $H = (61 \pm 1)$  HRC. After that, the samples went through surface grinding, polishing and lapping, resulting in a mirror finish with an average line roughness of  $R_a = 0.01 \mu\text{m}$ . The CrAlN coating was deposited using a combination of direct current magnetron sputtering (dcMS) and high power pulse magnetron sputtering (HPPMS), in an industrial coating unit CC 800/9 custom, Ceme-Con AG, Wuerselen, Germany. The coating architecture comprised of CrAl interlayer followed by a CrAlN top layer. Further details about process parameters and coating characterization methods can be found in [12] against the coating process CrAlN-3. The residual stress state of the coating was also measured using focused ion beam/digital image correlation (FIB/DIC) ring-core method, as explained in [13]. Fig. 1 shows the SEM image of the coating cross section along with interlayer and substrate.

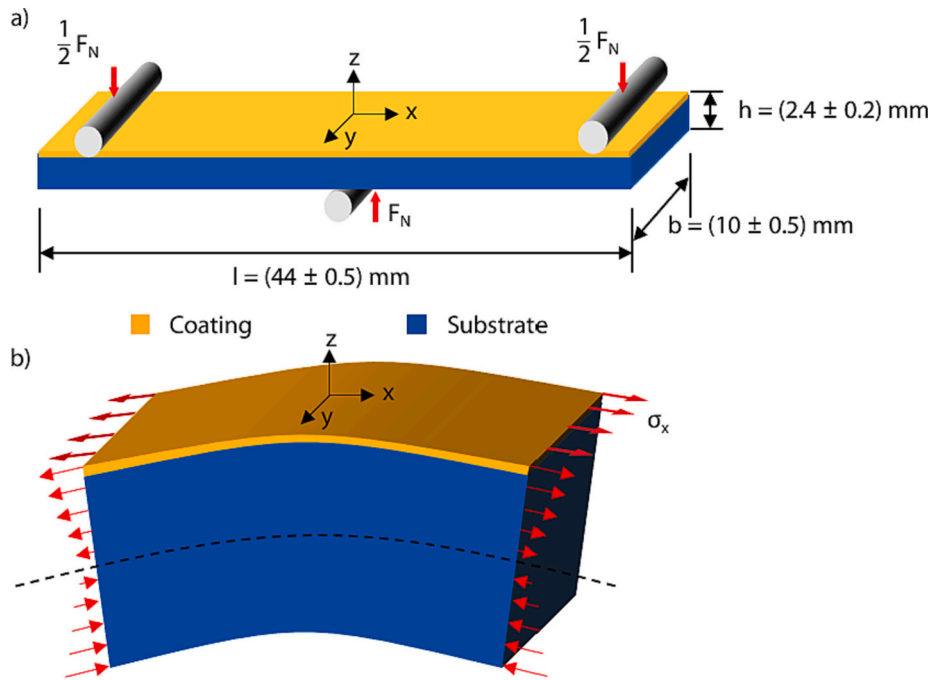
**Fig. 2.** a) Schematic of the 3-point bending test setup for cyclic bending tests at high stress amplitude along with b) stress distribution in x-direction on x-y plane and x-z plane of the sample during bending.

substrates was studied through cyclic bending tests at high as well as low stress amplitudes. For high stress amplitude, 3-point bending tests were carried out using bending module from Kammrath & Weiss GmbH, Schwerte, Germany, at GFE, RWTH Aachen University, Germany. Uncoated and coated rectangular samples having length  $l = (44 \pm 0.5)$  mm, width  $b = (10 \pm 0.5)$  mm and thickness  $h = (2.4 \pm 0.2)$  mm were used for this purpose. Fig. 2a) schematically represents the 3-point bending test setup. The tests were carried out with bending force  $F_N = 1.8$  kN, frequency  $f = 0.05$  Hz and loading ratio  $R \approx 0$ . The stress amplitude at these test parameters was  $\sigma_a \approx 1875$  MPa. With the loading ratio  $R \approx 0$ , the coated surface as well as the interface between coating and substrate

were subjected to a tensile stress in x-direction during bending, as shown schematically in Fig. 2b). The tests were repeated twice for each variant.

The results of 3-point cyclic bending tests, carried out as per Fig. 2, are shown in Table 3. All samples fractured between  $N = 274$  and  $N =$

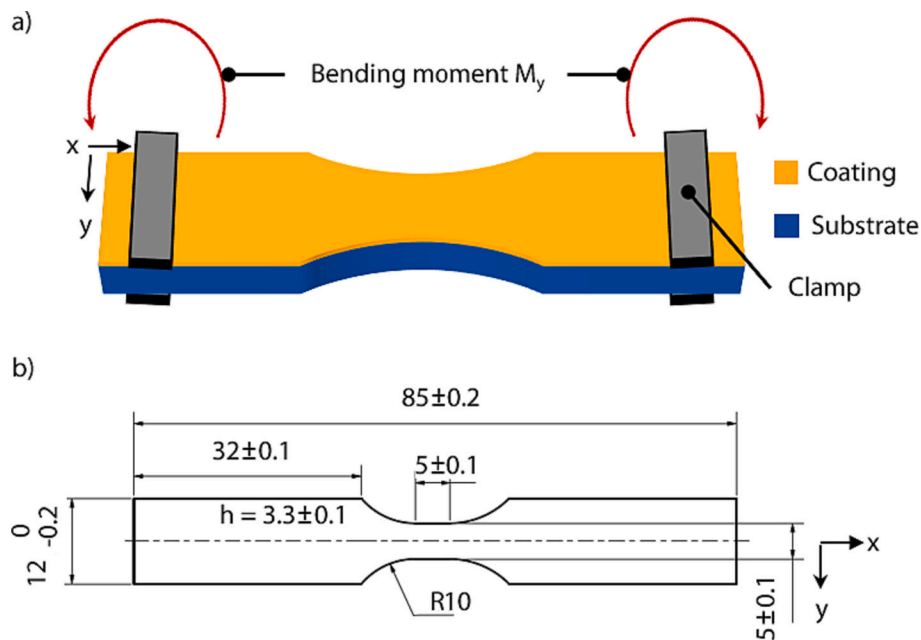
**Fig. 3.** a) Schematic of the test setup and b) sample dimensions in mm for cyclic bending tests at relatively low stress amplitudes.

The cyclic bending tests with comparatively low stress amplitudes were carried out at Chair of Materials Test Engineering (WPT), TU Dortmund University, Germany, using a resonance testing system, Rumul Cracktronic, from Russenberger Prüfmaschinen AG, Neuhausen am Rheinfall, Switzerland. Fig. 3 schematically shows the test setup along with the sample geometry. In order to comprehensively study the fatigue behavior of the investigated variants at low stress amplitudes, load increase and single step cyclic bending tests were combined as per the recommendation in [14]. Initially, the approximate range of

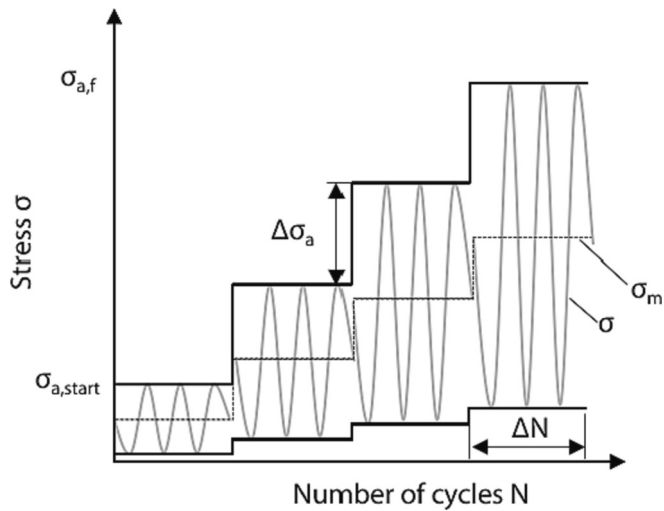
Fig. 4. Loading procedure of the load increase test (LIT).

endurance limit for the uncoated and coated samples was determined using a step wise load increase test (LIT). As shown schematically in Fig. 4, the LIT for both variants was started with stress amplitude  $\sigma_{a, \text{start}} = 100$  MPa, frequency  $f = 73$  Hz and stress ratio  $R = 0.1$ . The stress amplitude was increased by  $\Delta\sigma_a = 10$  MPa after every  $\Delta N = 10,000$  cycles until sample fracture. The uncoated sample fractured at  $\sigma_{a, f} = 770$  MPa, whereas the coated variant fractured at  $\sigma_{a, f} = 740$  MPa. Based on that, the single step tests were carried out at stress amplitudes  $\sigma_a = 720$  MPa,  $\sigma_a = 760$  MPa,  $\sigma_a = 780$  MPa,  $\sigma_a = 800$  MPa and  $\sigma_a = 820$  MPa with  $f = 73$  Hz and  $R = 0.1$ . The stress amplitude  $\sigma_a$  in single step tests was kept constant until the sample failure or  $N = 1 \times 10^7$  cycles, whichever occurred first.

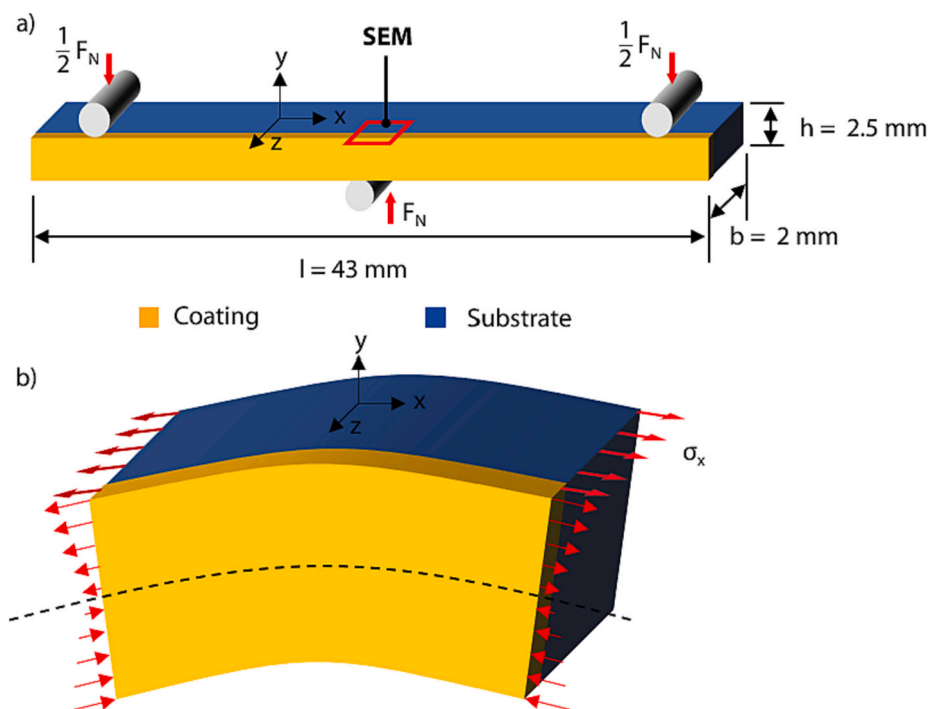
Fig. 5. a) Schematic of in situ monitoring test setup in large chamber SEM along with b) stress distribution in x-direction on x-y plane and x-z plane of the sample during bending.

In order to find out, whether the surface or subsurface fatigue cracks initiate in the coating or substrate, the x-y plane along with coating-substrate interface in x-z plane of sample in Fig. 2 were identified as areas of interest for in situ SEM observation during cyclic 3-point bending test. For this purpose, the bending module, previously used for high stress amplitude tests, was installed inside a large chamber SEM, Mira 1430 VP, VisiTec, Ellcie Industries GmbH, Grevesmühlen, Germany. Preliminary test was carried out with the loading direction shown in Fig. 2a), whereby the coated surface, i.e. x-y plane, was in situ analyzed from the top. However, the propagation of fatigue cracks on the surface could not be captured in this case. The used combination of bending module and large chamber SEM only allowed the in situ analysis from the top. Therefore, in order to observe the crack sensitive interface between the coating and substrate in x-z plane during the test, the sample was loaded as shown in Fig. 5a). It is important to note here, that in situ monitoring test was carried out to analyze the fatigue crack initiation in the coated compound rather than the fatigue limit. Although the sample was loaded differently than the test setup in Fig. 2a), the interface area, relevant for in situ observation of fatigue cracks, still underwent a tensile stress in x-direction during bending. Moreover, the test setup in Fig. 5a) presented the advantage to subject the interface, coating and substrate area, being observed under the large chamber SEM, to a uniform stress in x-z plane during bending, see Fig. 5b). This offered the possibility to analyze, whether the fatigue cracks, under a uniform tensile stress on the observed interface area, initiate first in the coating or substrate. Therefore, the in situ monitoring test represented a model test focused on basic research of fatigue crack initiation in interface area of coated compound under tensile bending stress. These findings, regarding the initiation of fatigue cracks, can also contribute to understanding the surface or subsurface fatigue crack initiation in the coated samples loaded differently, as in Figs. 2a) and 3a. Considering the sample size limitations of the bending module, a smaller sample was prepared for the in situ monitoring test, see Fig. 5a). The loading procedure of the test is shown in Fig. 6. The test was started with

length to identify other fatigue cracks. Several surface cracks were observed as marked by red arrows in Fig. 14a). Here the surface under investigation consists of coating, interface and substrate area, as schematically shown in Fig. 5. Fig. 14b) represents the EDX-map of Al to mark the coating. Fig. 14c-f) show the EDX-mappings based qualitative distribution of iron and carbide particles in the sample area from Fig. 14a). The large carbide particles and clusters are rich in tungsten, molybdenum and vanadium, see Fig. 14d-f). As reported in [17], W and Mo promote the formation of secondary  $M_6C$  and MC carbides upon heat treatment. Another series of carbide particle apparent from the EDX-Mappings are V rich. As explained in [17], vanadium promotes the formation of separate MC-type carbide precipitates. The same is true for the present case. Such large W, Mo or V containing carbide clusters are typical for high speed tool steels after heat treatment. As apparent from Fig. 14a), other identified fatigue crack sites are also concentrated around the carbide clusters in the substrate. The crack paths at the locations marked in Fig. 14a) are shown in Fig. 15. The crack at location 1 in Fig. 14a), which went through the large carbide cluster can be seen in Fig. 15b). This crack did not reach the coating. The black elliptical shaped area in the crack path presumably represents nonmetallic inclusions or hole resulting from decohesion of these inclusions. This could also be a possible initiation site for this crack. The crack path at location 2 in Fig. 14a) included the carbide cluster and the coating, see Fig. 15a), c) and d). The crack width increased in the CrAl metallic interlayer. Eventually, the crack width reduced as it travelled inside the CrAlN top layer. The Fig. 15e-h) represent the crack path for location 3 in Fig. 14a). Fig. 15e) and f) represent the upper end of the crack in reference to the coating while Fig. 15g) and h) focus on the lower end. Again, the crack path, passing through the large carbide cluster and nonmetallic inclusion, remained in the substrate. It is interesting to note that the crack width increased as it travelled through the carbide particles and decreased upon entering the surrounding Fe-matrix. Fig. 16 shows two additional locations where fatigue cracks were observed inside the large carbide particles at the coating/substrate interface. In both cases, the surface fatigue cracks did not propagate into the coating. This again points towards the ability of the coating, having compressive residual

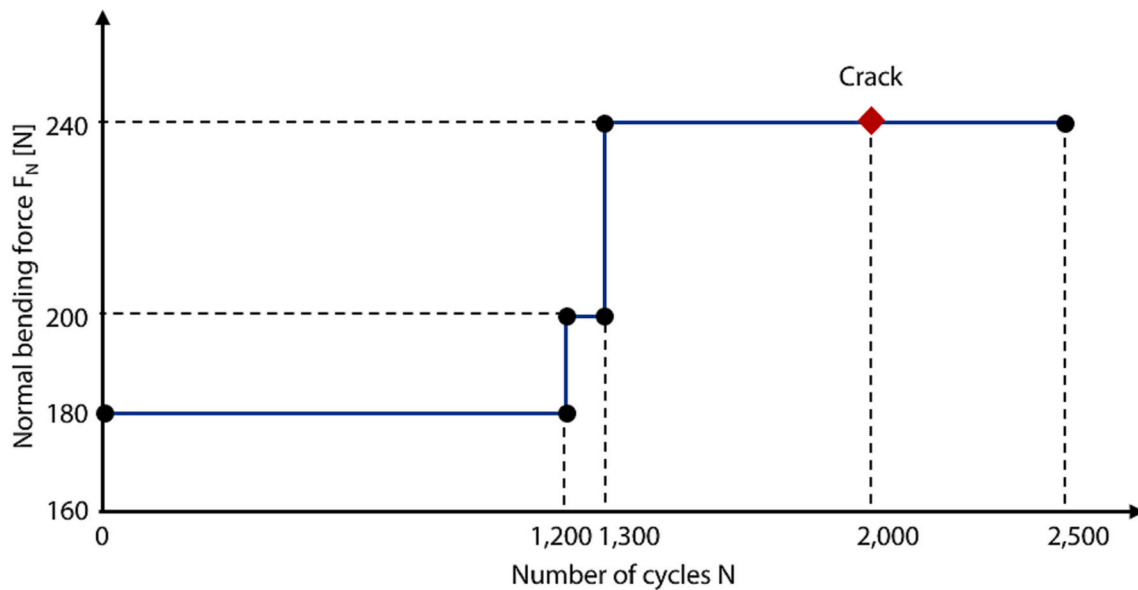
Fig. 6. Loading procedure of in situ monitoring cyclic bending test carried out in large chamber SEM.

an initial load of  $F_{N,start} = 180$  N, frequency  $f \approx 0.05$  Hz and loading ratio  $R \approx 0.4$ . In order to reduce the experimental effort associated with in situ SEM monitoring, the bending load was increased to  $F_N = 200$  N after  $N = 1200$  cycles and to  $F_N = 240$  N after  $N = 1300$  cycles due to the absence of crack evidence in the observed region. Eventually the fatigue crack was first observed at  $N = 2000$  cycles. The experiment was continued for  $\Delta N = 500$  cycles to further observe the damage propagation and finally stopped at  $N = 2500$  cycles without sample fracture. Afterwards, the sample was taken out of the experimental setup and analyzed in detail with a high-resolution SEM, ZEISS DSM 982 Gemini, Carl Zeiss AG, Oberkochen, Germany. The in situ monitoring test and the subsequent damage analysis were carried out at GFE, RWTH Aachen University, Germany.

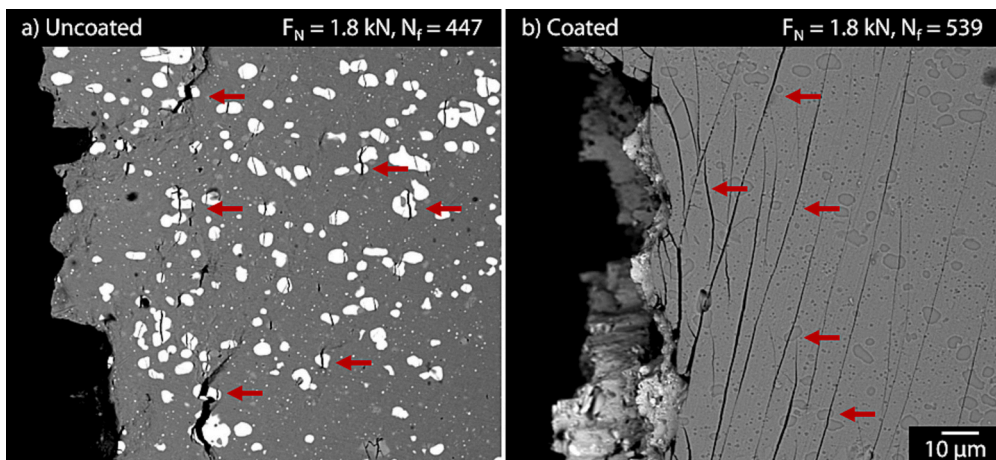
Fig. 7. SEM images of the surface around fracture area for (a) uncoated and (b) coated samples subjected to high stress amplitude 3-point bending test.

The damage analysis of the selected samples is shown in Figs. 7 and 8. Fig. 7 exemplarily shows the surface of the fractured half sample from above. Compared to the uncoated variant, the coated samples showed longer cracks on the surface around the fracture area. The cracks visible on the uncoated HS6–5-2C surface are shorter in length and seem to be concentrated around the carbide phases. The cross-section images of the fractured uncoated substrate revealed several cracks running through or around the carbide particles, Fig. 8a) and b). In case of the coated variant, the fracture area did not exhibit any significant coating delamination or cracks running along the interface between coating and substrate. Fig. 8c) exemplarily shows that the coating remained mostly intact in the fracture area. Moreover, the surface or subsurface cracks ran through the coating, see Fig. 8d) and e). Hereby, two types of cracks were observed. The first type, as seen in Fig. 8d), were contained solely in the coating without any propagation into the substrate. The second type of cracks, as seen in Fig. 8e) and f), revealed a crack path including coating and substrate. At this stage, it remains unclear whether the crack initiated in the coating or substrate. However, in general, the cracks observed in the cross-section of coated samples were mostly concentrated around carbide phases in the substrate. Moreover, the bending tests at high stress amplitude revealed no significant effect of coating on the fatigue strength of the substrate.

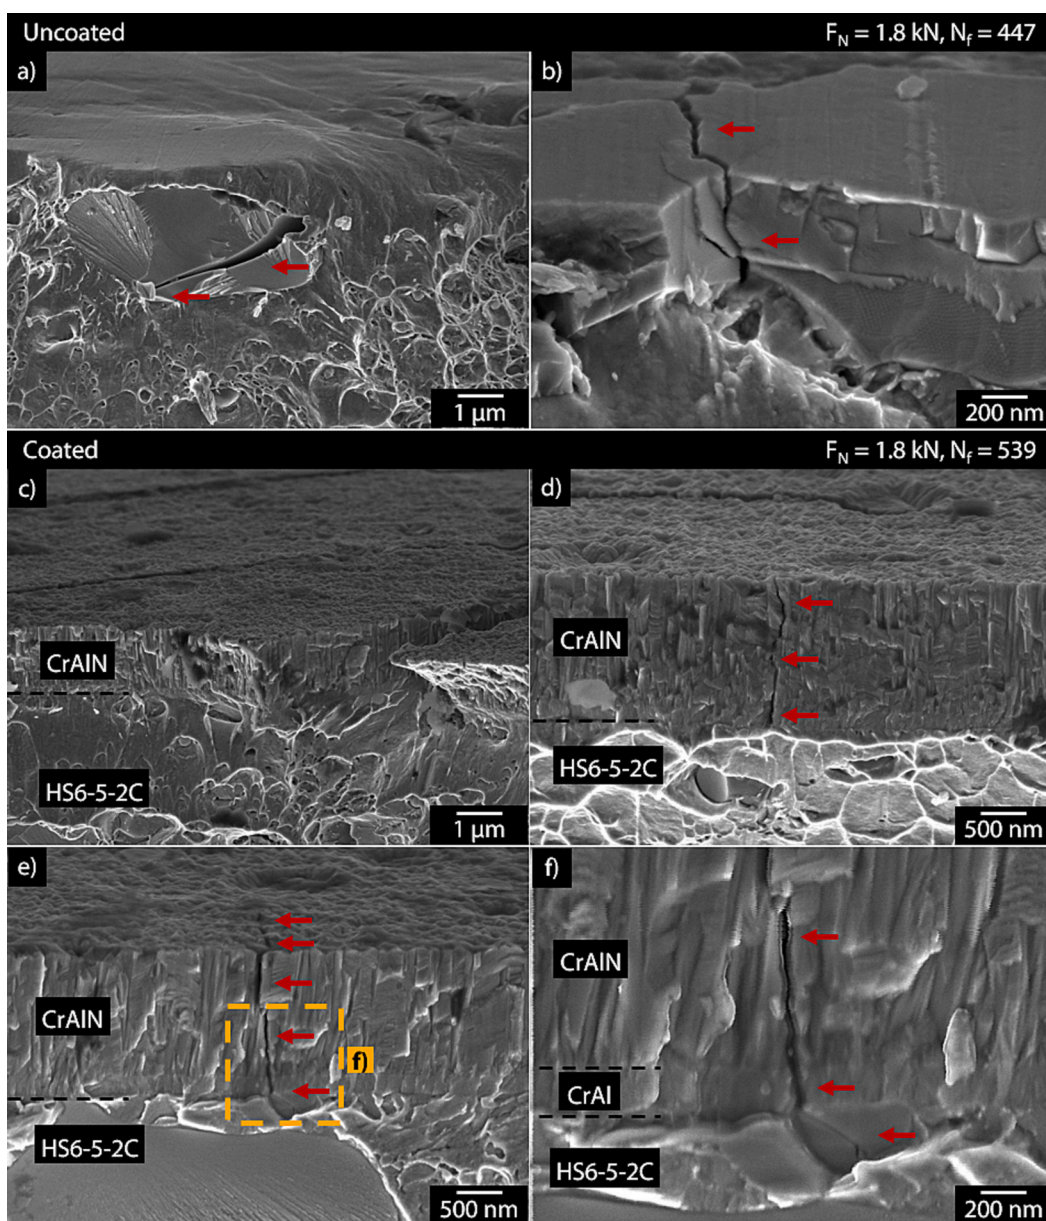
Fig. 8. SEM images of the fracture cross-section of (a-b) uncoated and (c-f) coated samples subjected to high stress amplitude 3-point bending test.

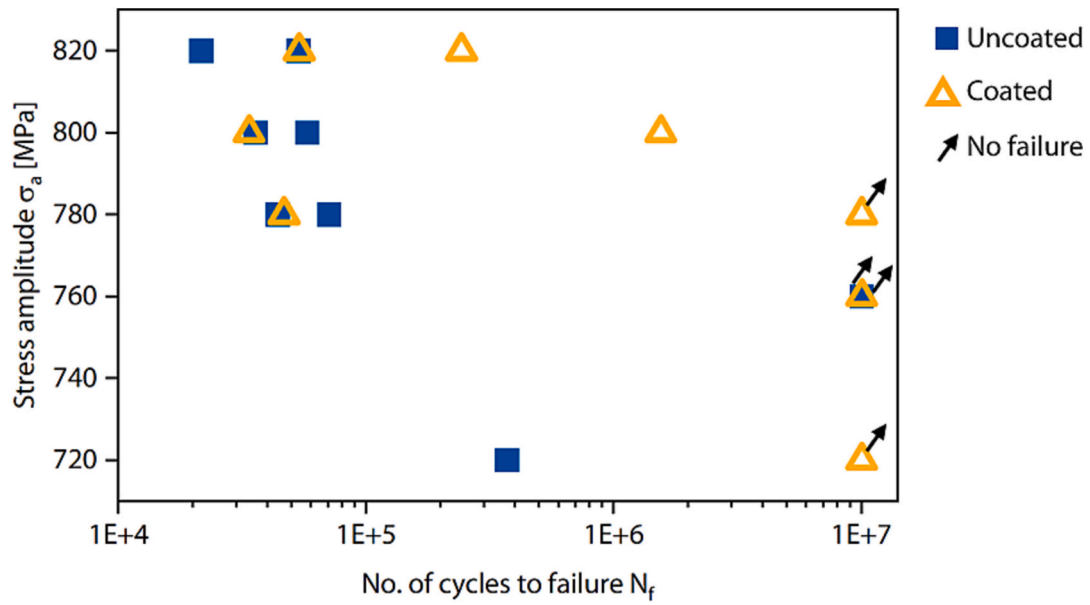
Fig. 9. Results of single step cyclic bending tests for uncoated and coated samples at low stress amplitudes.

The results from cyclic bending tests at low stress amplitudes are shown in Fig. 9. With exception of one uncoated sample at  $\sigma_a = 760$  MPa, which did not fail after  $N = 1 \times 10^7$  cycles, the endurance limit for the tested uncoated samples could be below  $\sigma_a = 720$  MPa. On the other

hand, the coated samples seem to have a higher endurance limit,  $\sigma_a \approx 760$  MPa. The single step tests at  $\sigma_a \geq 780$  MPa were repeated to examine the effect of coating on fatigue behavior of coated samples above the endurance limit of coated samples. The single step tests for uncoated samples showed a good repeatability in number of cycles to

failure  $N_f$  at  $\sigma_a \geq 780$  MPa. Interestingly, the coated samples showed a large deviation in fatigue behavior. Either the sample failed in a similar range as the uncoated variant or it exhibited a significant increase in the number of cycles to failure. This deviation in number of cycles to failure  $N_f$  for coated variants reduced as the stress amplitude increased from  $\sigma_a$

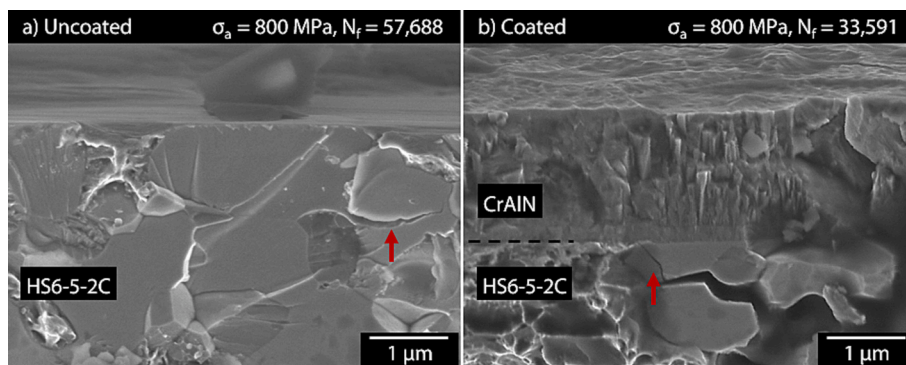
Fig. 10. Fracture cross-section SEM images of (a) uncoated and (b) coated samples after single step cyclic bending test at  $\sigma_a = 800$  MPa.

= 780 MPa to  $\sigma_a = 820$  MPa. Hence, the fatigue behavior of the coated variants seems to be approaching that of uncoated substrate as stress amplitude increases. The damage analysis of the fracture surface of the samples showed small surface cracks for uncoated and large surface cracks for coated variant, as previously observed in Fig. 7. Moreover, no surface cracks were observed on the coated samples which did not fracture until  $N = 1 \times 10^7$  cycles. Fig. 10 exemplarily shows the cross-section images of the fracture area for selected samples. Again, for uncoated variant, the cracks were mostly concentrated around the carbide particles, see Fig. 10a). As opposed to the coated samples tested at high stress amplitude, the observed coated variants subjected to low stress amplitudes did not reveal any cracks running through the coating cross-section. As shown in Fig. 10b), the coating remained mostly intact without any major cracks running through the coating. However, it is interesting to see a crack, marked by red arrow, running through the carbide particle in the substrate without further propagation into the coating. The fracture cross-sections of the coated variants showing a deviation in number of cycles to failure  $N_f$  at the same stress amplitude  $\sigma_a$  were also compared. The samples which withstood significantly larger number of cycles to failure showed locations with adhesive coating damage along the fracture area. Fig. 11a) and b) exemplary show the adhesive damage and cohesive plus adhesive damage, respectively, for the sample subjected to  $\sigma_a = 800$  MPa. This sample showed a significant increase in number of cycles to failure,  $N_f =$

1,549,683, compared to the uncoated samples as well the second coated sample. However, these locations with adhesive damage of the coating were absent for the second sample which failed at  $N_f = 33,591$  cycles, see Fig. 10b).

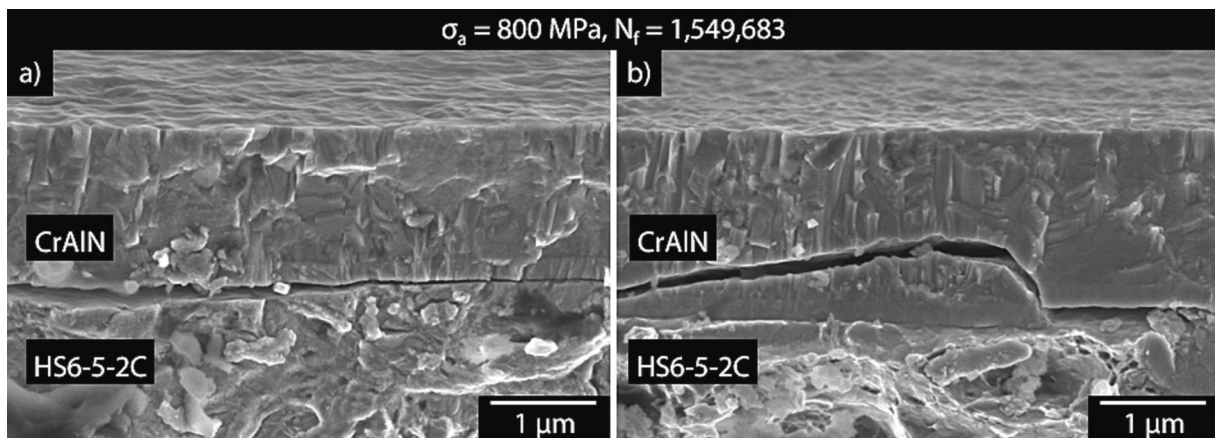
Fig. 11. SEM images of the a) adhesive and b) cohesive plus adhesive coating damage along the fracture cross section for the coated sample, which showed significant increase in fatigue life during single step cyclic bending test at  $\sigma_a = 800$  MPa.

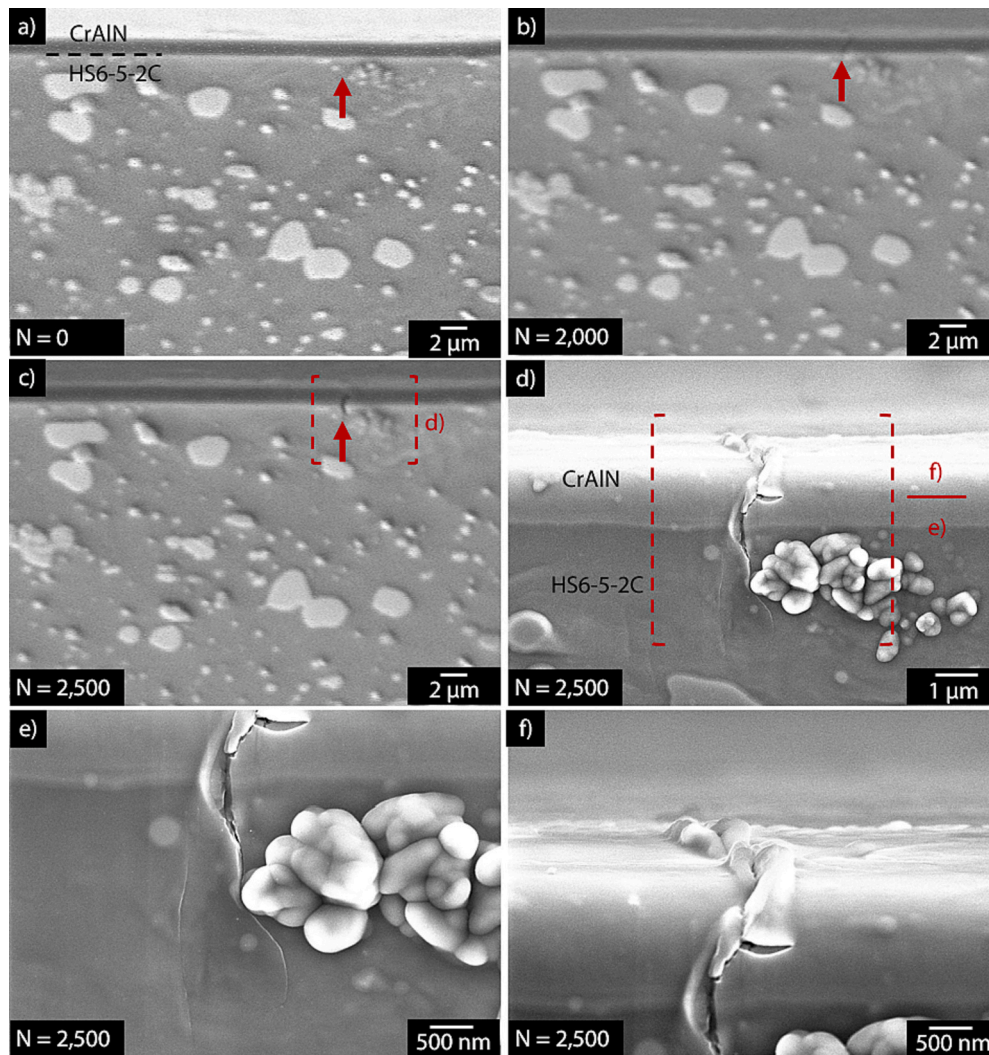
Fig. 12. In situ images from large chamber SEM (a) at the start, (b) after  $N = 2000$  cycles and (c) after  $N = 2500$  cycles of the test along with (d-f) high-resolution SEM images of the identified crack location.

Fig. 12a), b) and c) show the in situ images from the test in large chamber SEM. The location on which the crack appeared is marked in Fig. 12a). The crack was first observed after  $N = 2000$  cycles, see Fig. 12b). Eventually, the test was stopped after  $N = 2500$  cycles to analyze the crack propagation in detail, see Fig. 12c). Fig. 12d), e) and f) show the high-resolution SEM images of the observed fatigue crack location. It can be seen that the crack path is concentrated around the carbide cluster in the substrate and the coating. However, it is unclear whether the crack initiated in the coating or substrate. As qualitatively confirmed by the EDX analysis, the carbide cluster showed peaks for carbide forming tungsten, molybdenum and vanadium, see Fig. 13. Moreover, the presence of small calcium peak also pointed towards the presence of nonmetallic inclusions in the carbide cluster. These large carbide particles or clusters and nonmetallic inclusions can act as fatigue crack initiation sites for high-speed tool steels [15,16]. In order to clarify whether the fatigue crack initiated in the coating or substrate, the area around the coating/substrate interface was analyzed along the sample

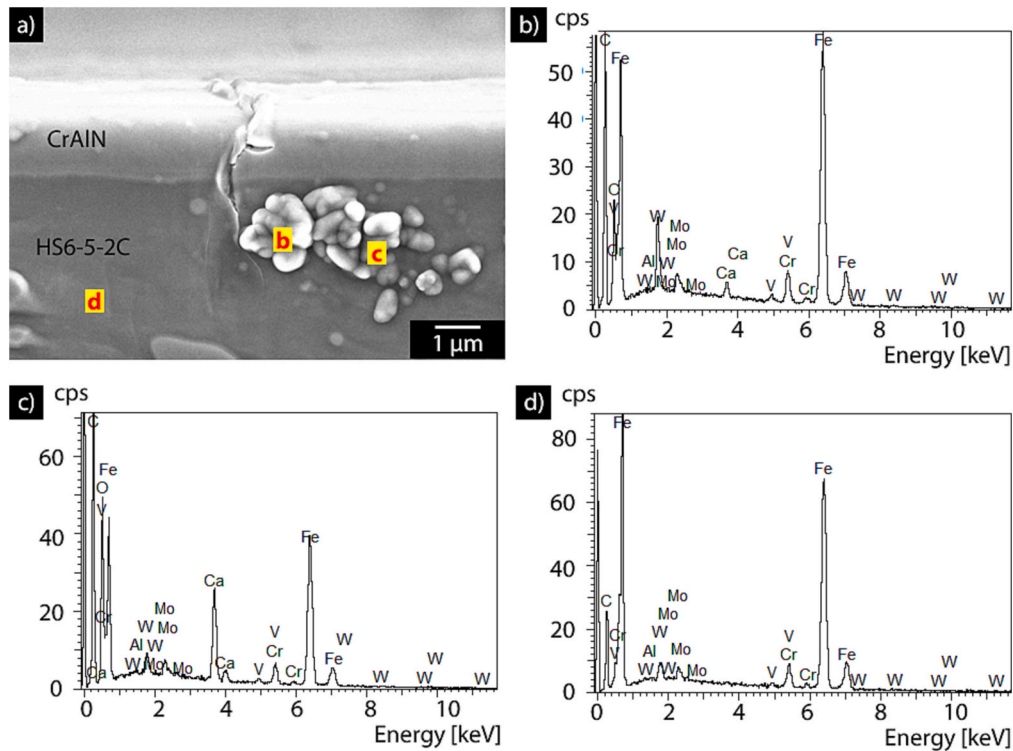
Fig. 13. a) Identified crack location during in situ monitoring test along with the qualitative EDX analysis of points b), c) and d).

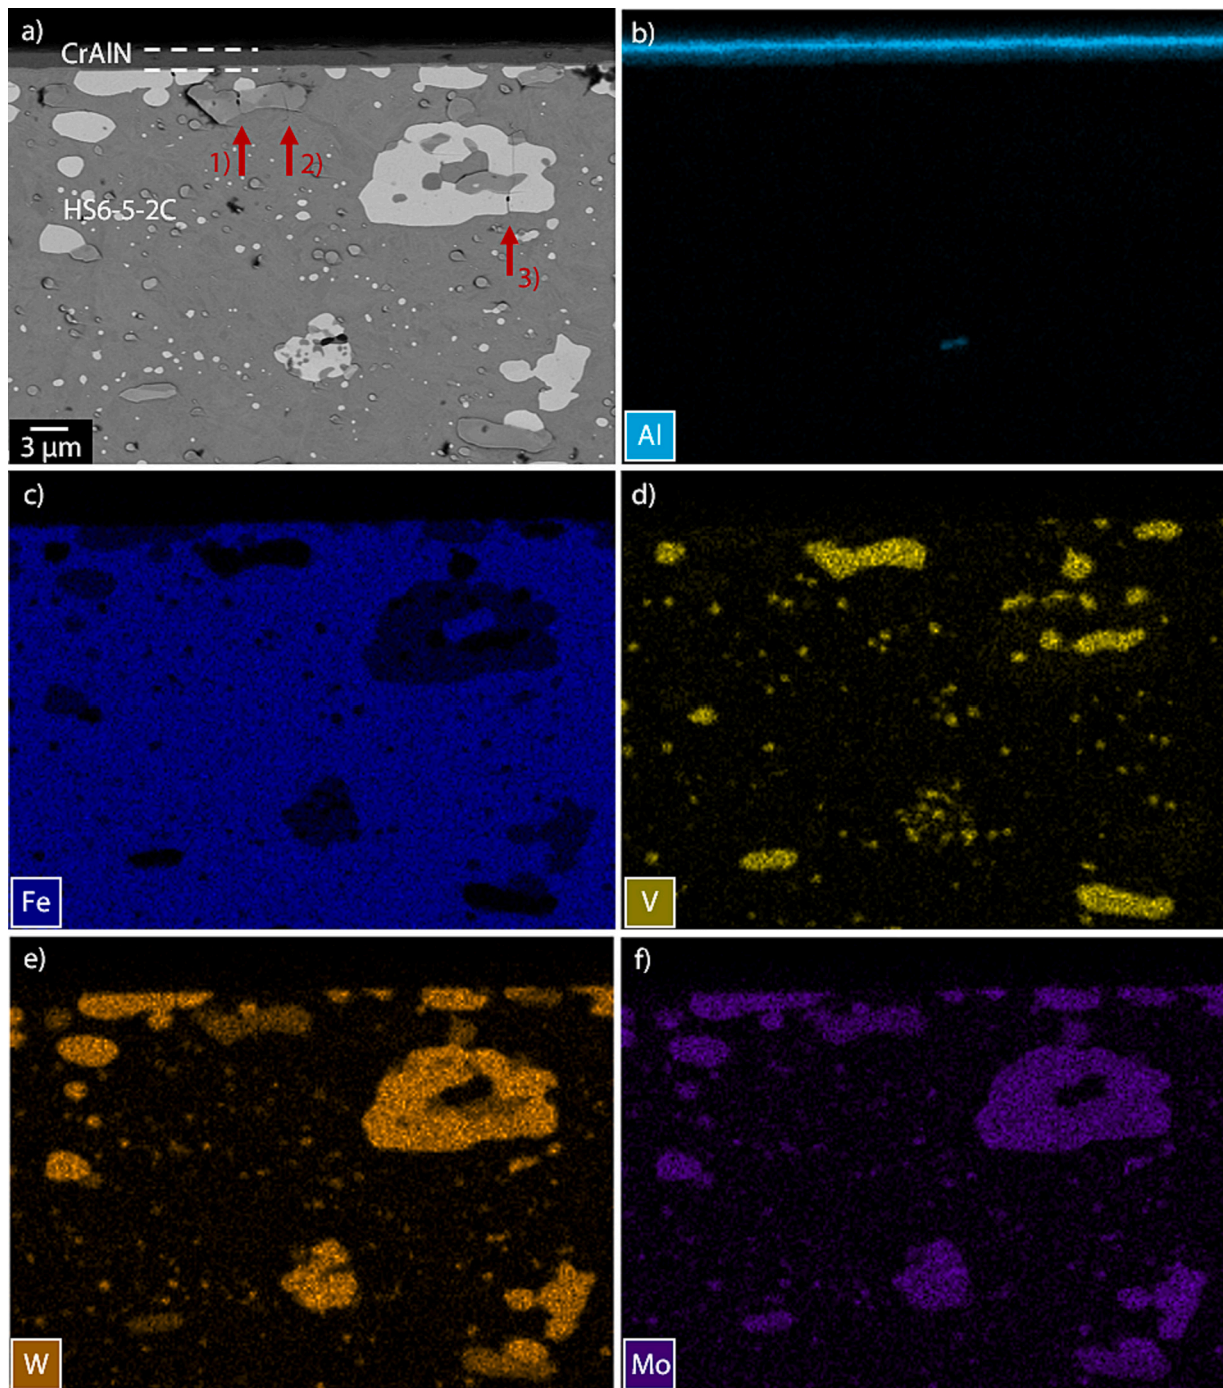
**Fig. 14.** (a) Crack locations marked with red arrows along with EDX-mapping of (b) Al, (c) Fe, (d) V, (e) W and (f) W of the area around fatigue crack locations for the sample subjected to in situ monitoring cyclic bending test.

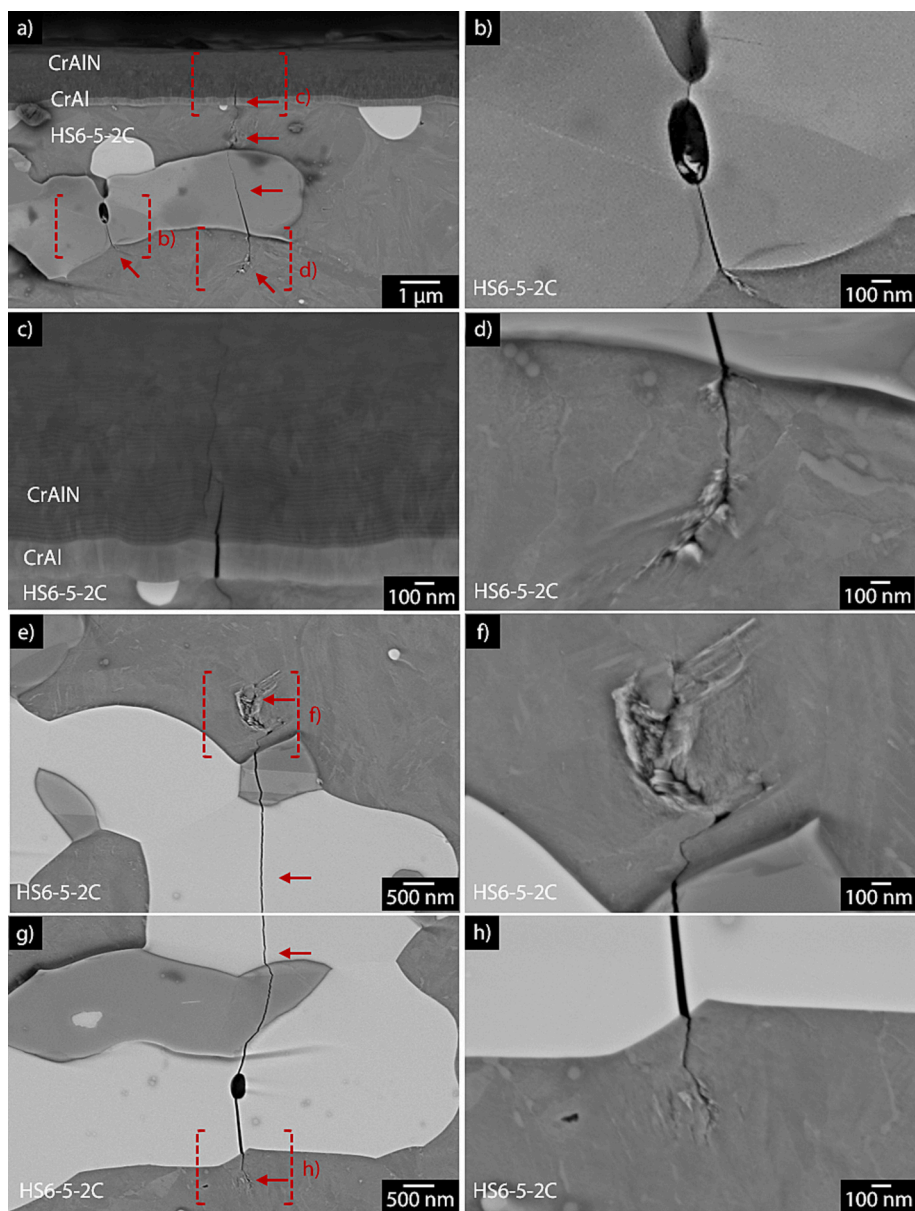
Fig. 15. Crack paths for the fatigue cracks observed at location 1 (a-b), location 2 (c-d) and location 3 (e-h) in Fig. 14a.

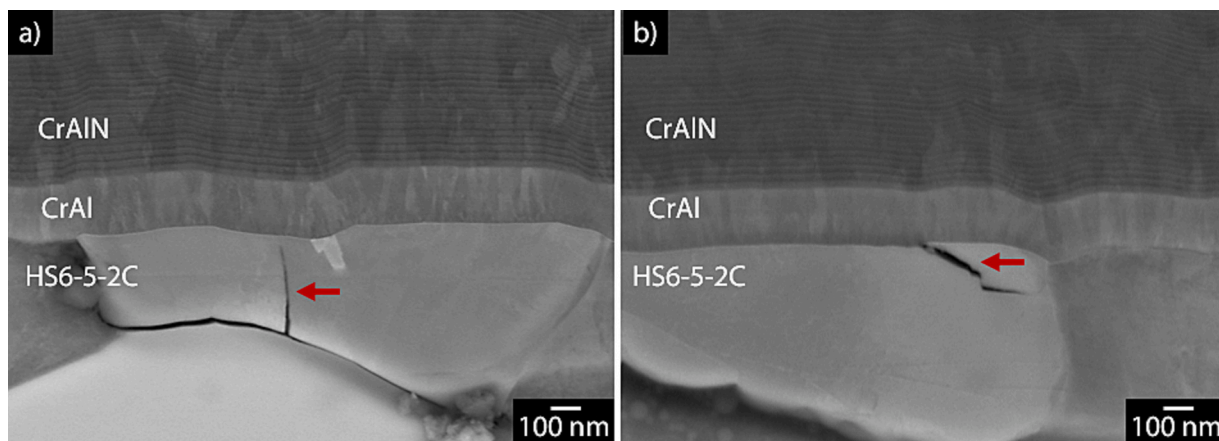
Fig. 16. Fatigue cracks observed on the interface between coating and substrate for the sample subjected to in situ monitoring cyclic bending test.

stresses, to resist the substrate driven fatigue cracks to a certain extent. It is important to note that the damage analysis did not reveal any locations where the fatigue cracks were solely contained in the coating.
